# INDOOR AIR QUALITY ASSESSMENT

## **Marsh Grammar School**

309 Pelham Street

January 2025

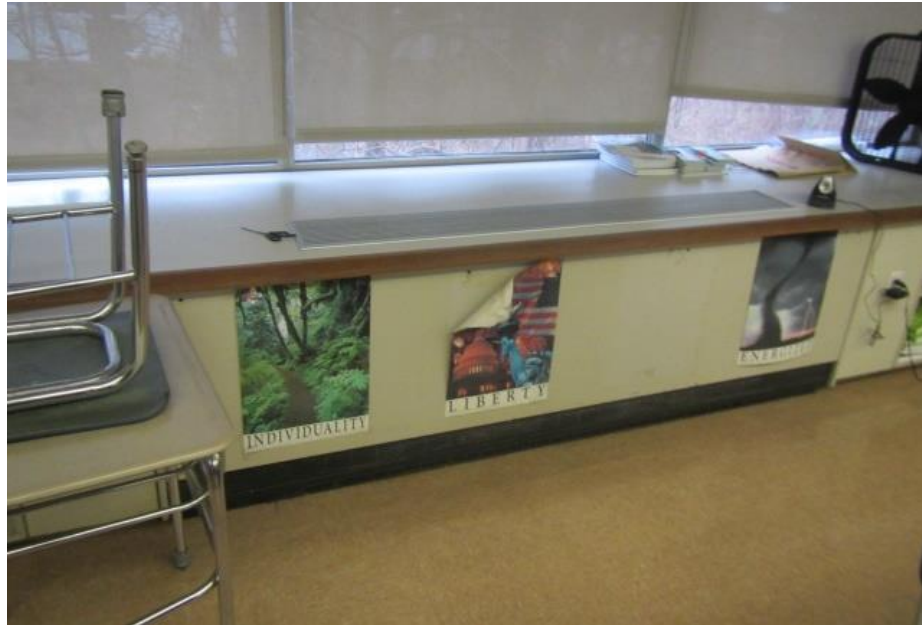
Picture 1

Univent in classroom

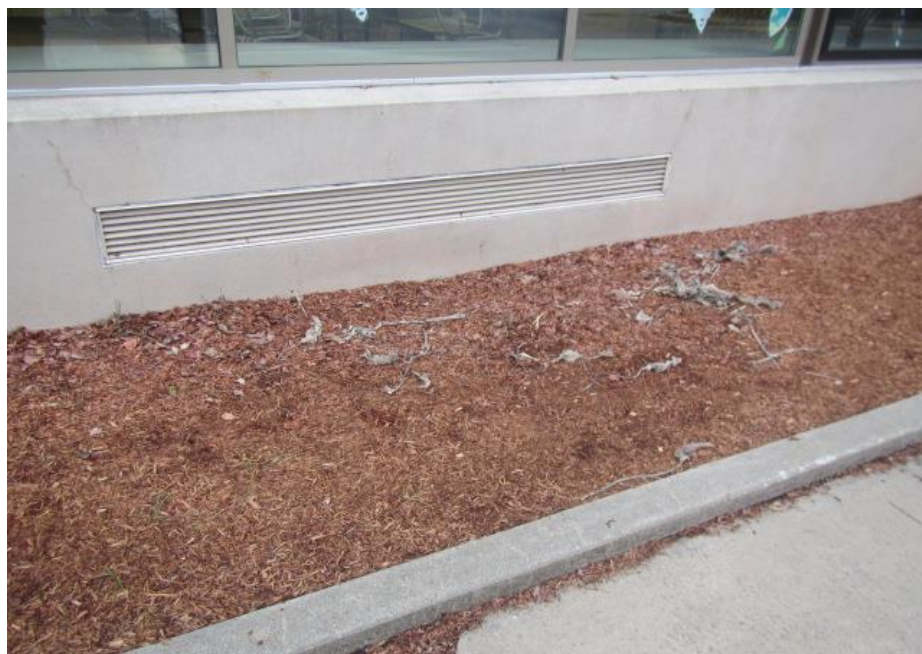
Picture 2

Univent fresh air intake

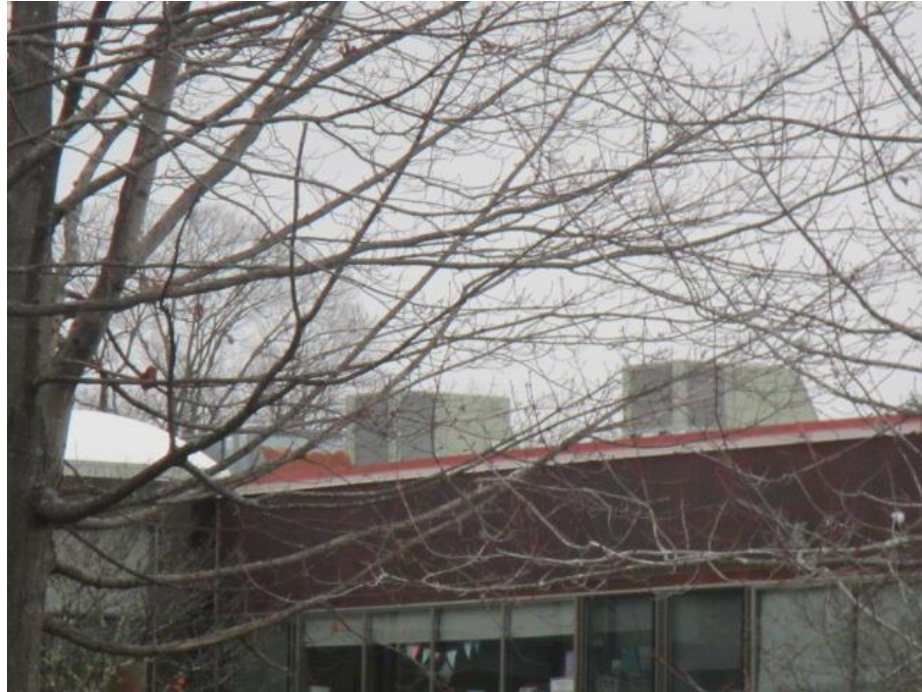
Picture 3

Examples of rooftop air handling units

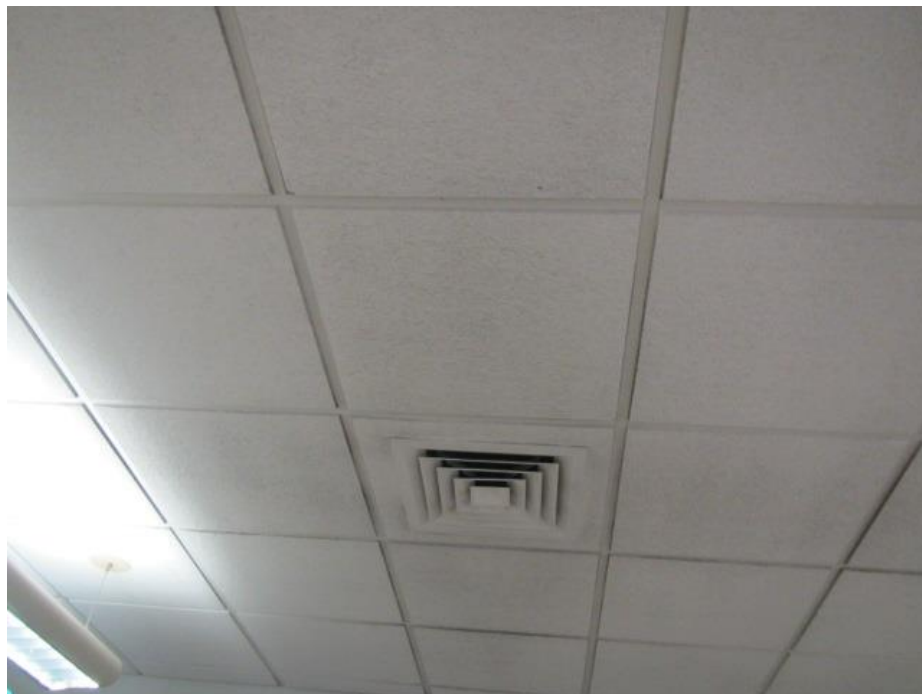
Picture 4

Ceiling-mounted supply diffuser

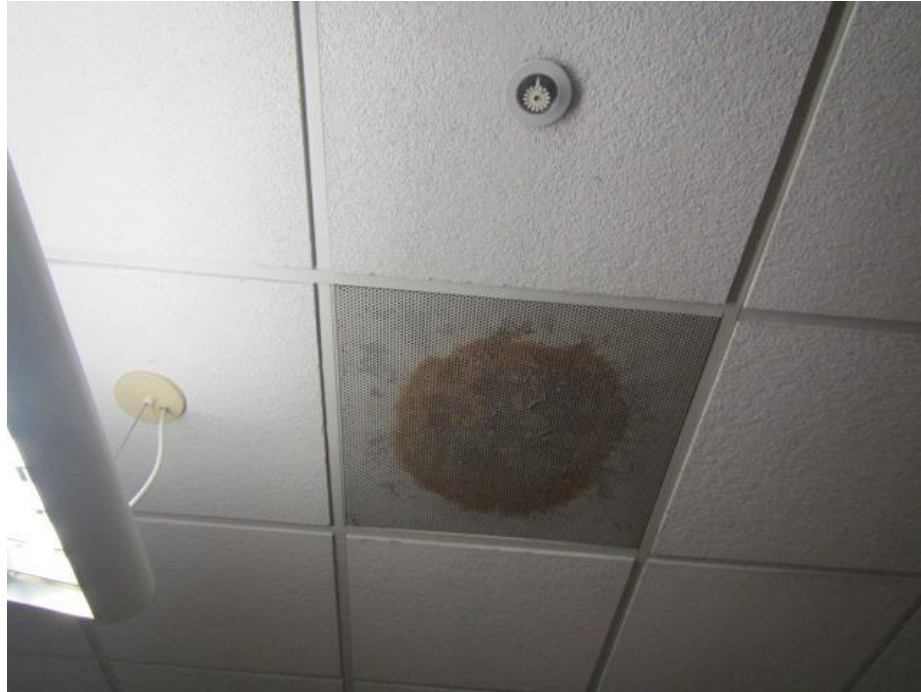
Picture 5

Ceiling-mounted return vent in classroom, note corrosion/staining

4.	Close classroom doors for improved exhaust vent function and air exchange.	
5.	Replace corroded exhaust screens as shown in Picture 5.	
6.	Change HVAC filters 2-4 times a year using MERV 8 or the best MERV-rating that can work with current equipment.	<a href="#">ANSI/ASHRAE Standard 52.2-2017</a>

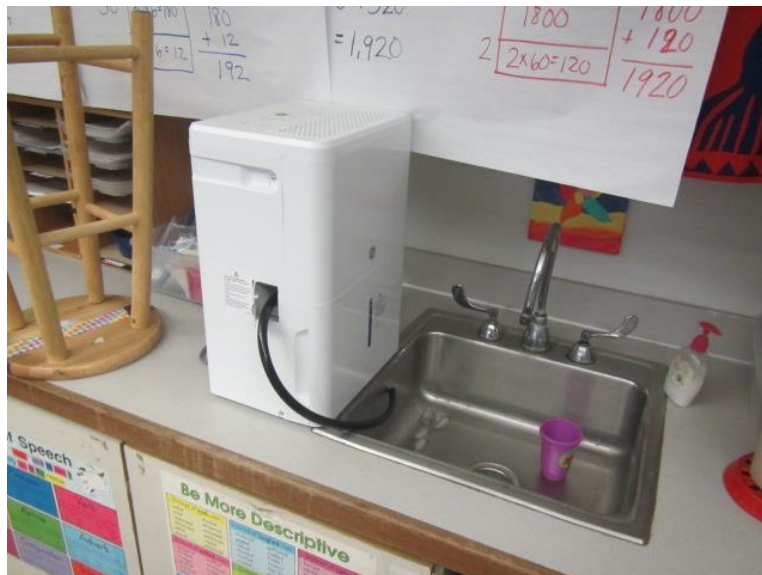
Picture 6

- The deployment of dehumidifiers in classrooms most susceptible to moisture. These dehumidifiers are stationed on countertops to allow continuous drainage into sink drains (Picture 6);
- Long-term replacement of carpeting;
- The use of MERV 13 filters in HVAC equipment;
- Making high-efficiency particulate arrestance (HEPA) air purifiers available for use. These remove up to 99% of airborne contaminants as small as 0.1 microns including airborne mold spores; and
- Plans to add new windows for the original 1969 building to a capital repair list.

Dehumidifier stationed on countertop to allow continuous drainage into sink drain

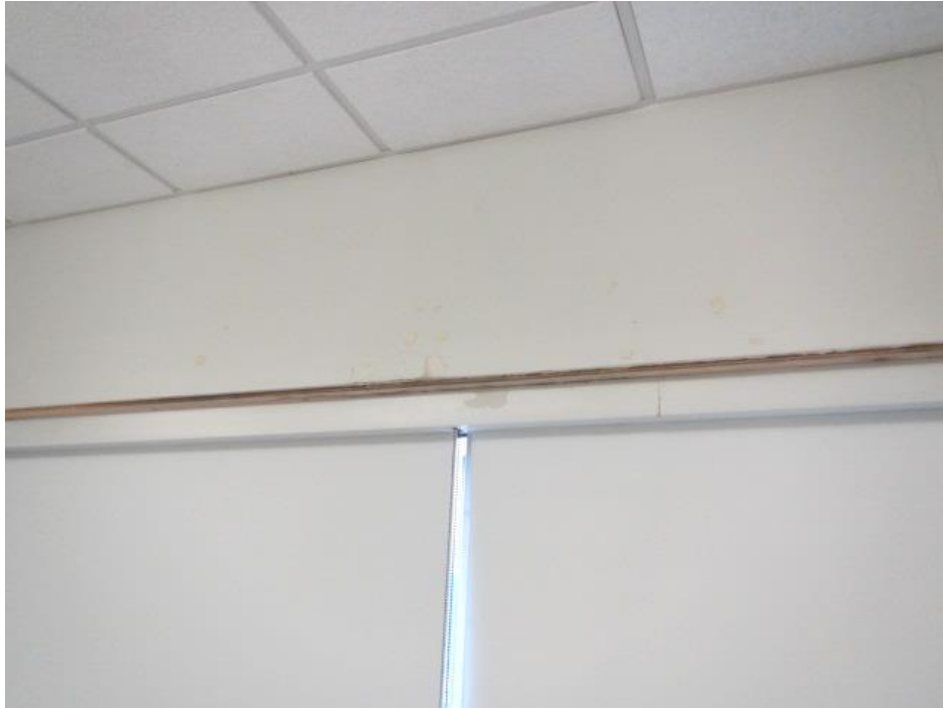
Picture 7

- **Room 216:** Water-damaged shelving units and gypsum wallboard along the ceiling above the windows were observed in this area (Picture 7).
- **Room 107 (located directly below 216):** The leaks from room 216 traveled directly below to Room 107 causing water damage to shelving units and visible mold on the surface of wooden cabinets (Pictures 8 through 10). The wood was recommended to be removed and discarded. The shelving units in both rooms 216 and 107 were recommended to be pulled out away from the wall over the Christmas vacation to inspect and remediate any further water damage and/or mold growth that may be present.

Water-damaged gypsum wallboard above windows in Room 216

13.	Monitor ceiling tiles (around vent) in hallway outside Room 107 for further water damage.	
14.	If not already completed, remove water-damaged cabinets in Rooms 216, 107, the Media Center (and other affected areas) to examine conditions behind them. Clean and/or replace as necessary.

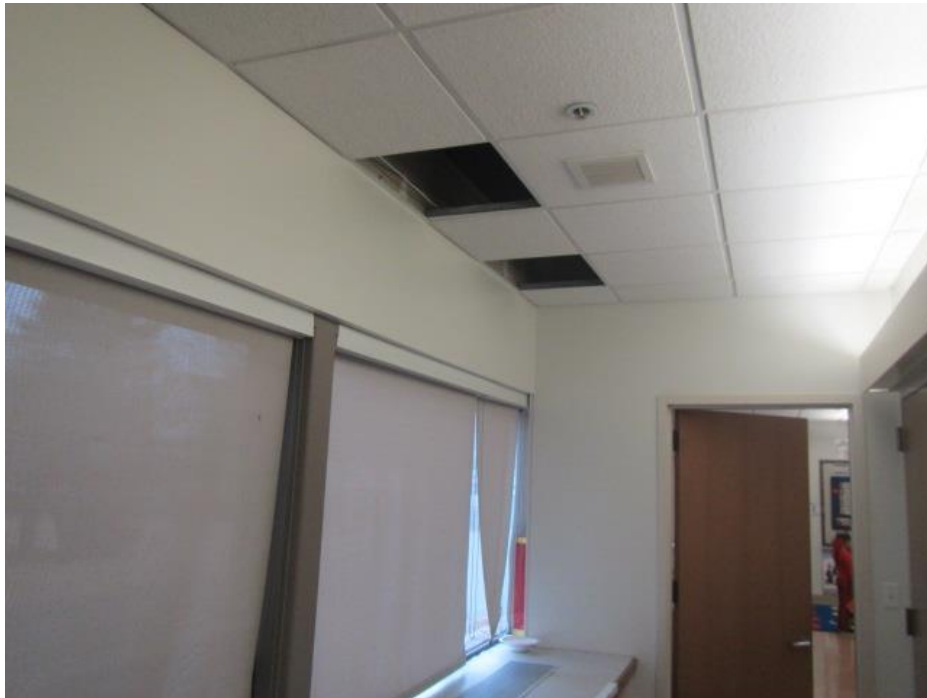
Picture 8

Areas of water leaks in room 107

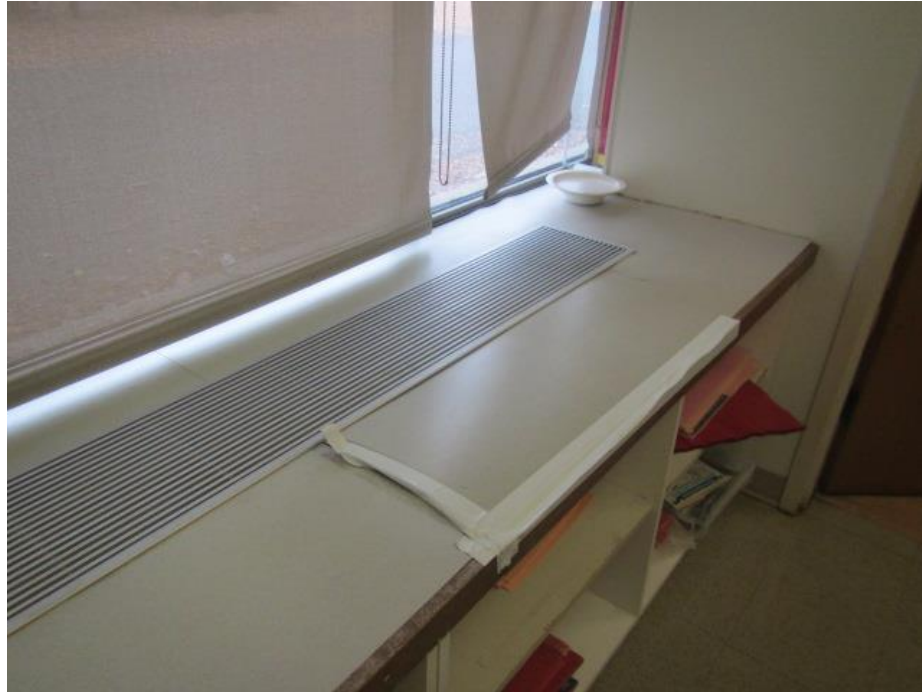
Picture 9

Water-damaged countertop below water leaks (from 216) in room 107

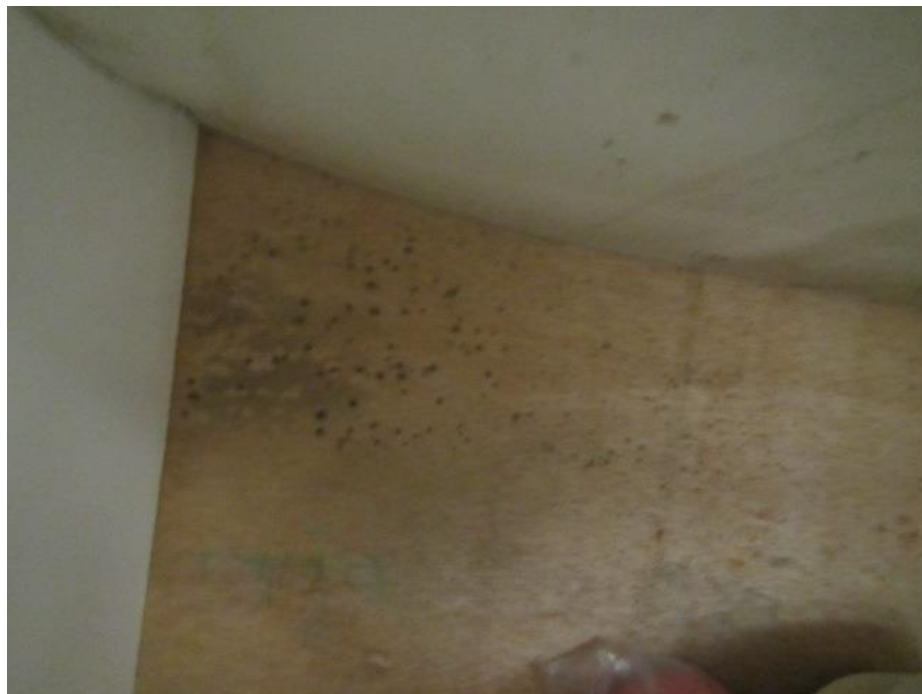
Picture 10

Small dark spots indicate likely mold on plywood cabinet in Room 107

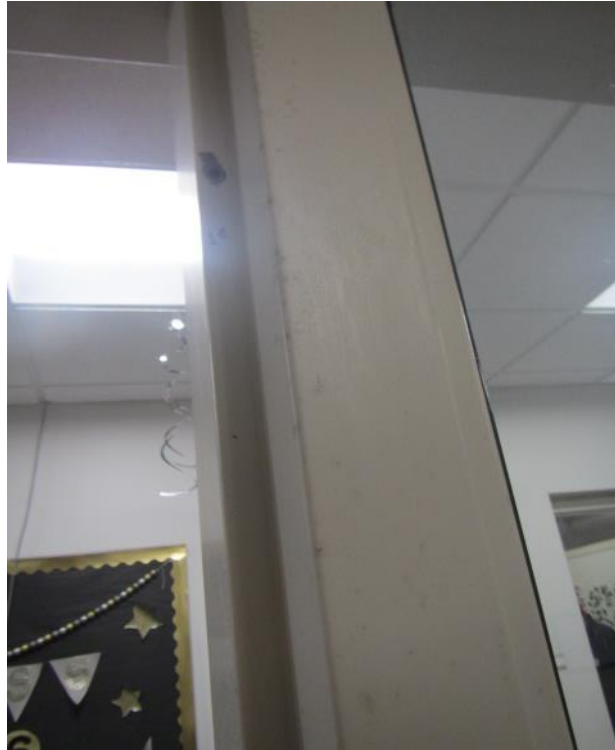
Picture 11

- **Guidance Suite:** Visible mold growth was observed on the surface of metal door jambs and on the bottom of a chair (Pictures 11 and 12). These materials are non-porous and should be cleaned with a mild antimicrobial product or a wet cloth. It is likely that dust and debris (which include naturally-occurring mold spores) collected on these surfaces which got moistened during periods of elevated relative humidity, causing mold growth.

Mold growth (spotting) on metal door jambs in Guidance Suite

15.	Monitor the Guidance Suite during periods of elevated relative humidity. Keep doors shut to the hallway and door jambs clean of dust and debris. To reduce relative humidity levels, adjust AC and/or use dehumidifiers as needed.

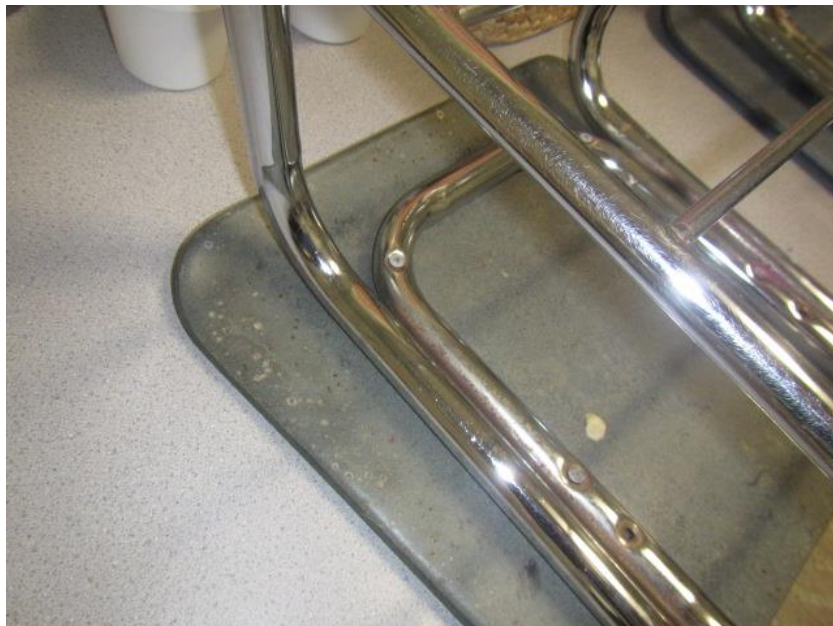
Picture 12

Spots (likely mold growth) on bottom of chair in Guidance Suite

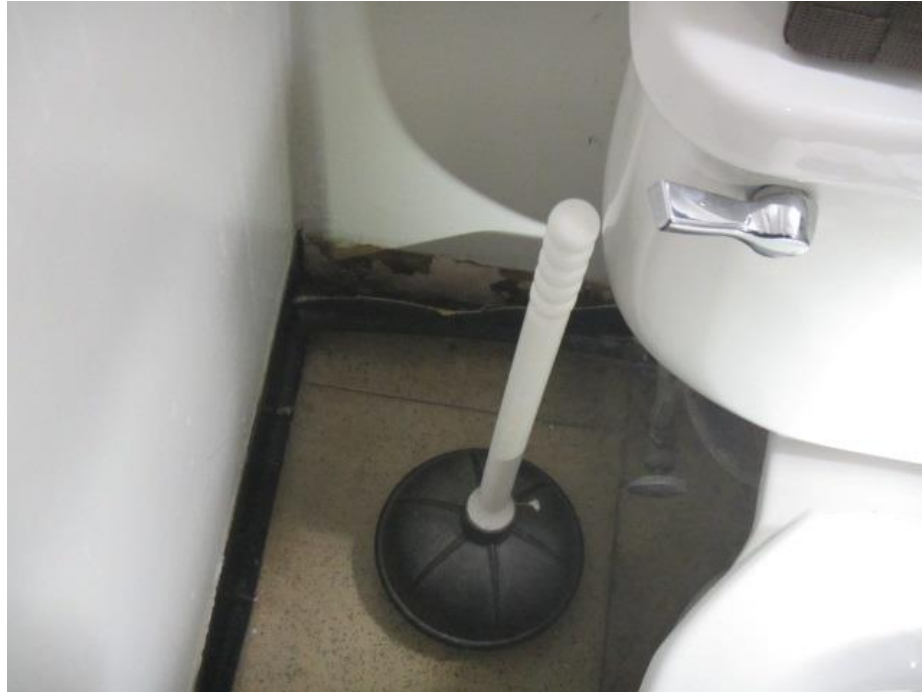
**Picture 13**

- **Restroom outside Media Center:** Visible mold was observed behind failing coving along the floor (Picture 13) due to chronic moisture or previous leaks from the toilet. This wallboard was recommended to be removed and replaced with a water-resistant material such as cement board.

**Visible mold observed behind coving in the restroom outside the Media Center**

16.	Remove mold-colonized gypsum wallboard in restroom outside Media Center and replace with a water-resistant material such as cement board.	
17.	Remove and replace water-damaged particleboard under sinks.

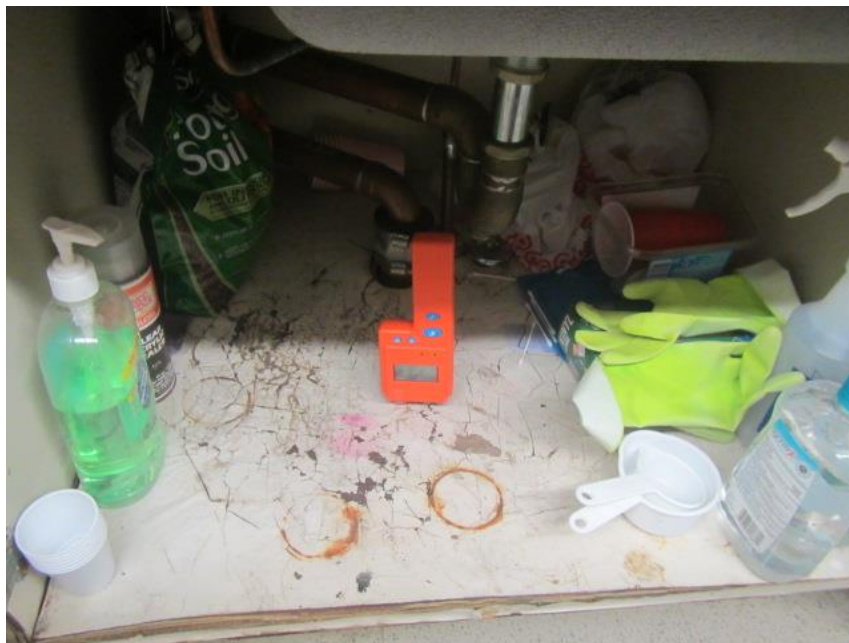
**Picture 14**

- **Water-damaged wood was noted under sinks in a number of classrooms (Table 1, Picture 14).** Although this wood was dry (tested via moisture meter) at the time of

assessment, in some cases the wood was severely damaged, beyond repair and should be removed and replaced. Uneven surfaces cannot be adequately cleaned, and any breaches can serve as pathways for pests and rodents into occupied areas.

**Water-damaged particle board under classroom sink**  
**Note: moisture meter indicating wood was dry at time of assessment**

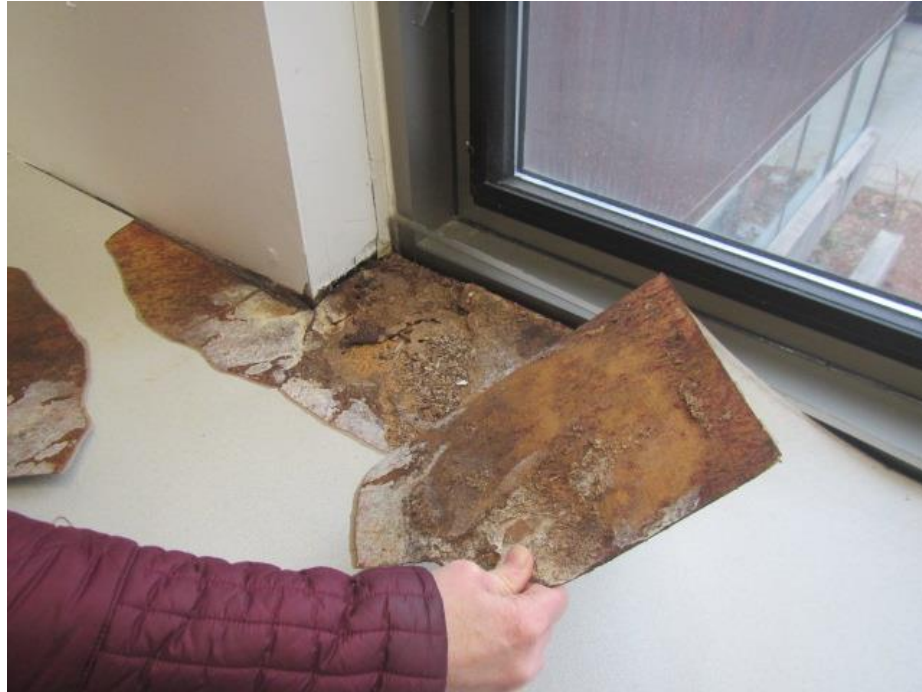
**Picture 15**

- **Severely water-damaged wooden surfaces were also noted in the Media Center (Picture 15).**
- **Signs of water infiltration were noted around a skylight in the hallway outside Room 143 (Picture 16).** The gypsum wallboard was dry at the time of the assessment. Mottled (spotted) staining was noted around the skylight, which appeared to be surface mold.

**Water-damaged surfaces near windows in Media Center**

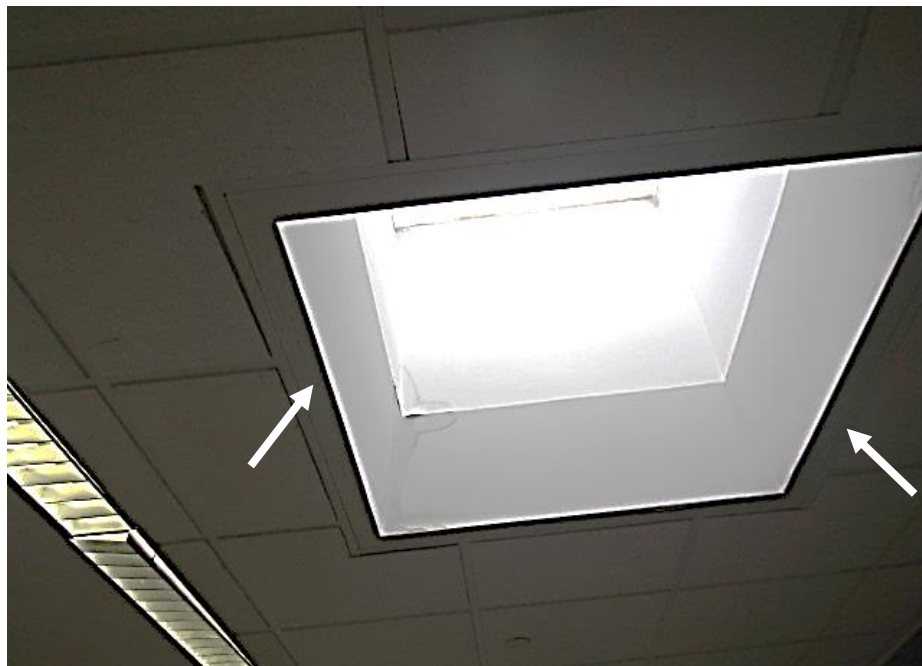
**Picture 16**

**Water-damaged gypsum wallboard around skylight**  
**Note: light mold growth was noted on the surface around skylight (arrows)**

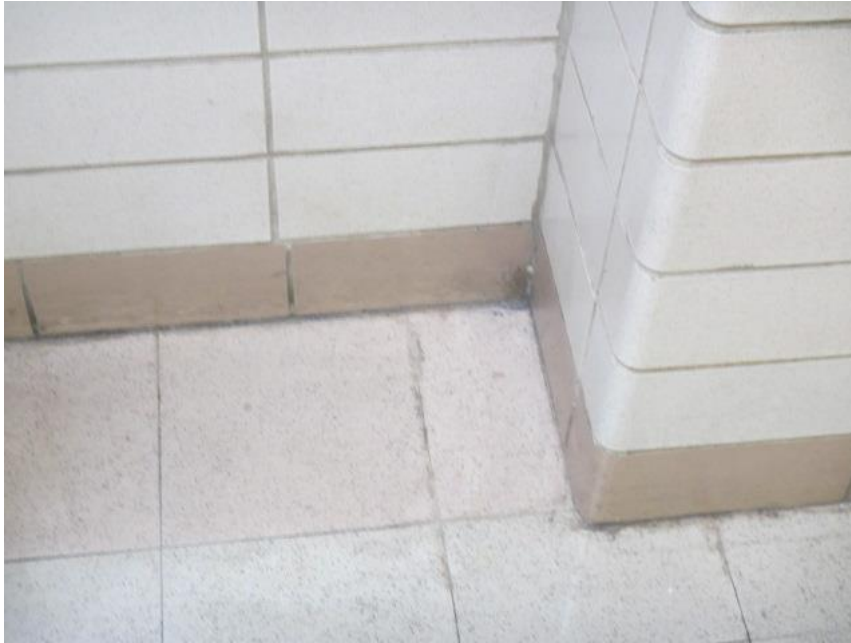
**Picture 17**

- **This area was also reported to be an area of water infiltration through floor tiles during heavy rains due to a high water table (Picture 17).** Building materials in this general area are mostly non-porous materials that are not conducive to mold growth (e.g., concrete and tile). However, this area should be kept clean of dust and debris (which can grow mold) and should be monitored after heavy rains to ensure prompt clean up and drying, and avoid moisture spreading to other areas with porous building materials, which may be conducive to mold growth.

**Area of water infiltration in hallway outside of Room 143**

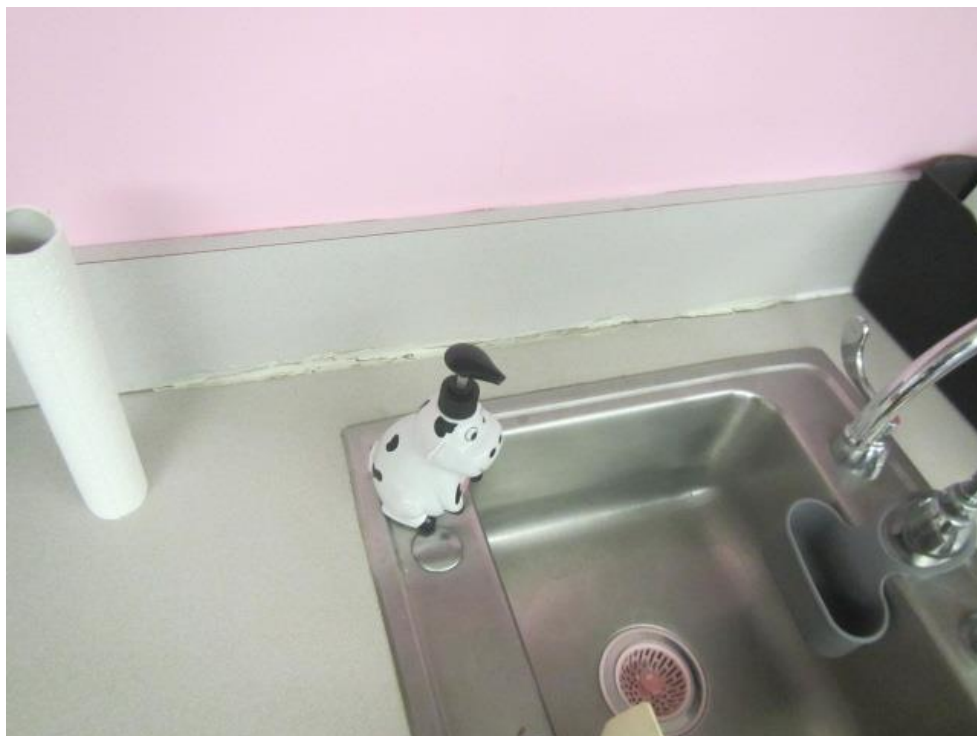
**Picture 18**

- **In one classroom missing/damaged caulking was noted between the backsplash and sink countertop (Picture 18),** which can lead to water damage and mold growth underneath.

**Missing/damaged caulking around classroom sink**

20.	Replace missing/damaged caulking around classroom sinks.	
21.	Conduct a thorough building envelope evaluation to make repairs/repointing efforts to eliminate leaks. Building occupants should ensure they report active leaks to building management for investigation and repairs.

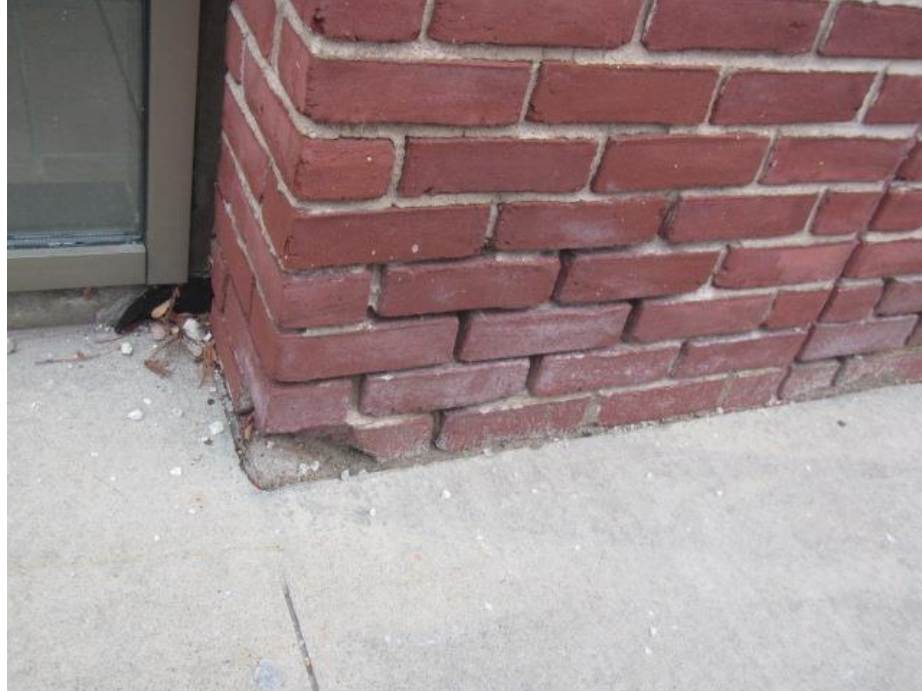
**Picture 19**

- **Missing/damaged mortar around brickwork needs repointing (Pictures 19 through 21).**
- **Damaged wood and delaminating paint/stain were found along the roof eaves and trim around windows (Pictures 22 through 24),** which can accelerate water damage and rot allowing a pathway for drafts, moisture, and pest entry into the building.

**Missing/damaged mortar around exterior brick**

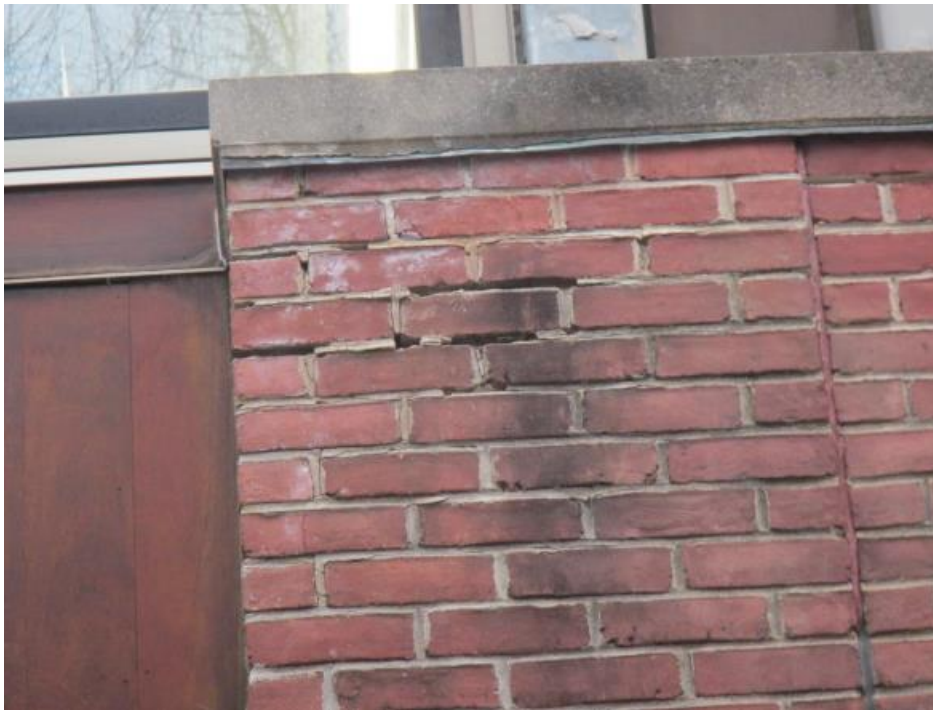
**Picture 20**

**Missing/damaged mortar around exterior brick**

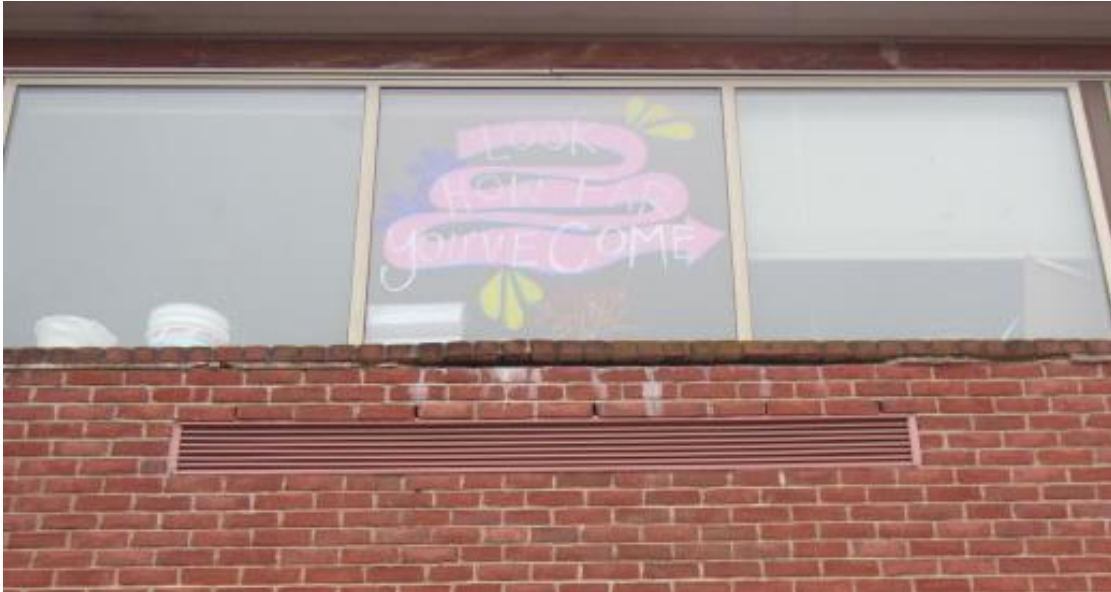
Picture 21

Missing/damaged mortar around exterior brick/below windows, possible source for water infiltration damaging cabinets and other interior building materials

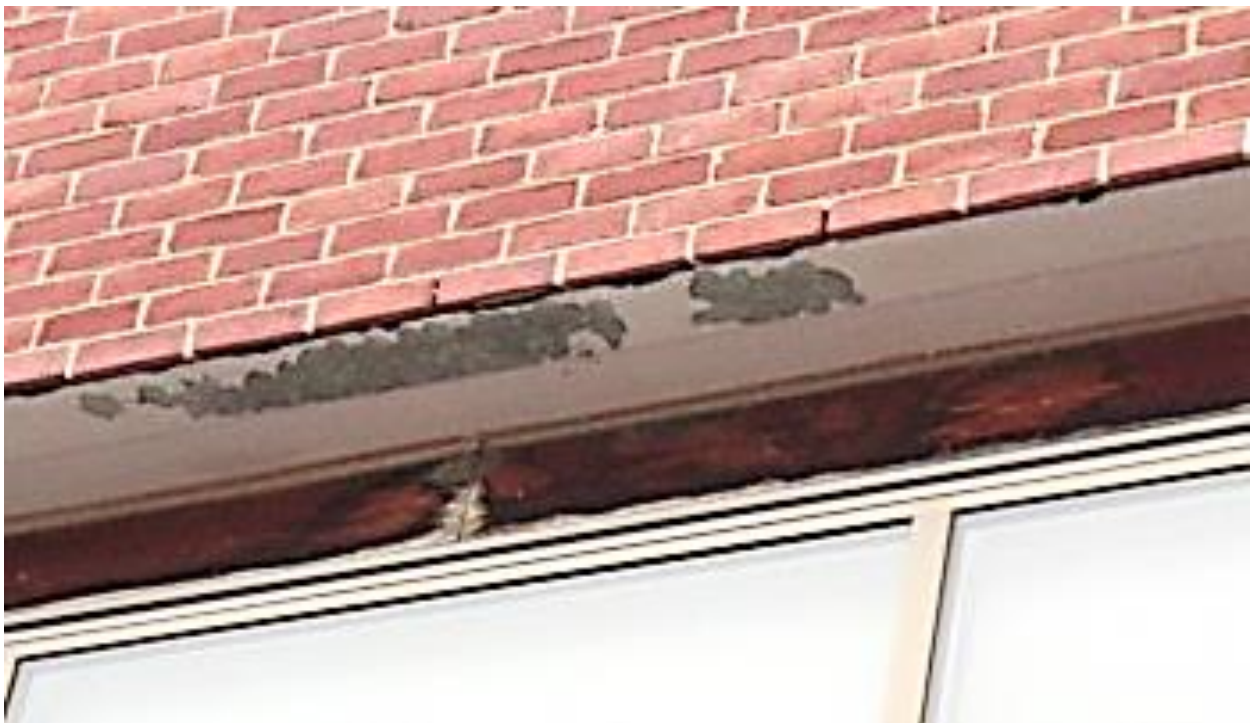
Picture 22

Delaminating paint/stain exposing wood around windows

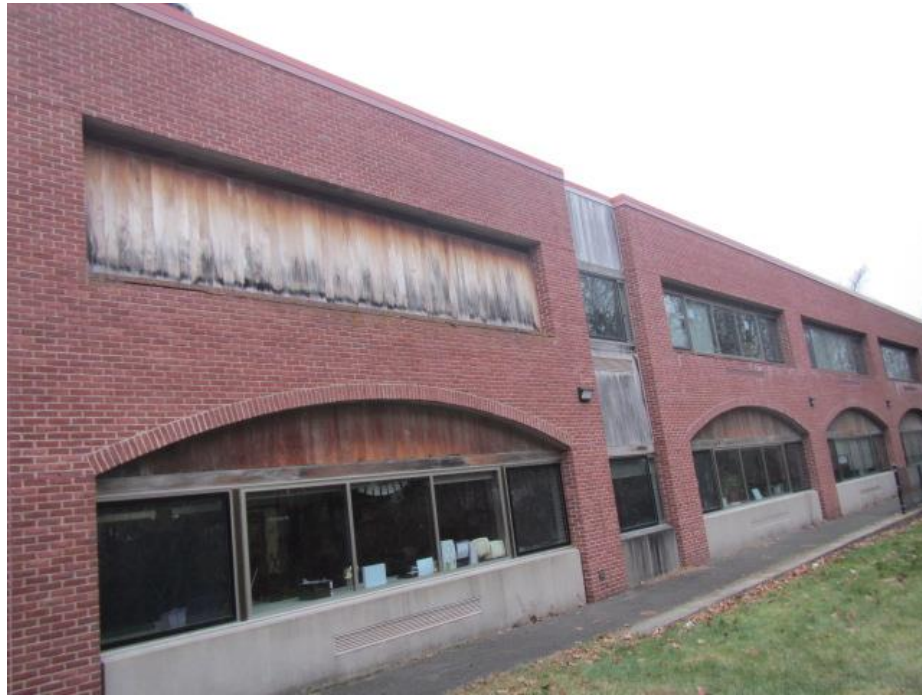
**Picture 23**

**Delaminating paint/stain exposing wood covering windows in original 1969 portion of building**

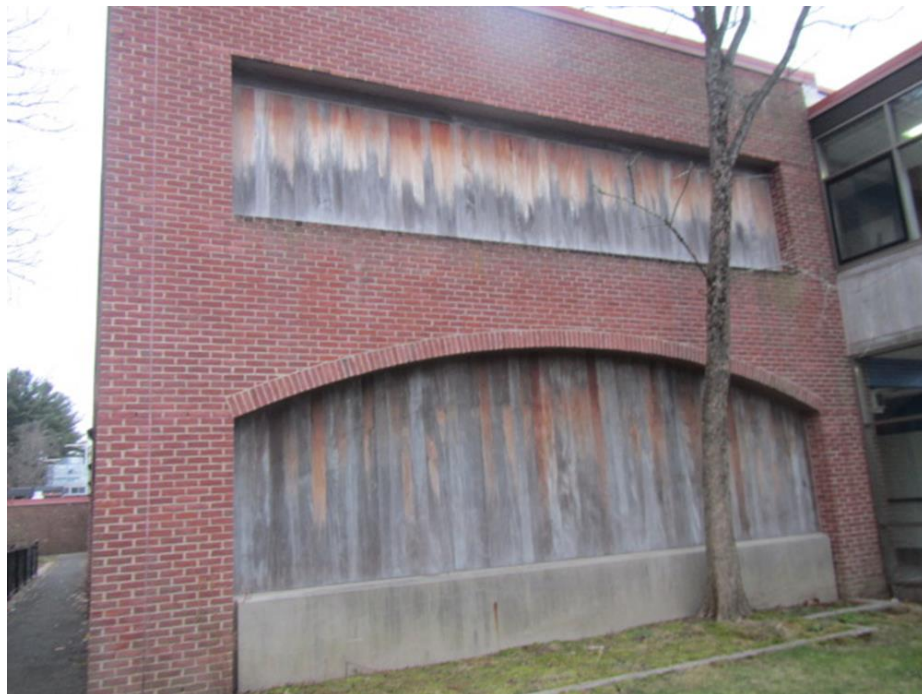
**Picture 24**

- **Plant/tree growth was noted along the seam between the concrete foundation and tarmac surrounding the building (Pictures 24 through 26).** Plants near the building can cause water damage to brickwork and mortar. In addition, plants shading exterior walls can slow drying. Water can eventually penetrate the brick, subsequently freezing and thawing during the winter. This freezing/thawing action can weaken and damage bricks and mortar.

- **The presence of trees near the building (Picture 24) pose several hazards/issues:**
  - Leaves and other debris accumulate around roof drains, which inhibits rainwater drainage from the roof. Ineffective drains can lead to water leaks inside the building.

**Delaminating paint/stain exposing wood covering windows in original 1969 portion of building, also note close proximity of tree to foundation/exterior wall**

- The Federal Emergency Management Agency (FEMA) provides several recommendations to prepare for severe thunderstorms. Of note FEMA recommends “Cut down or trim trees that may be in danger of falling on your [building]” (FEMA, 2018). Given the proximity to exterior walls, removal of trees from the exterior should be strongly considered.

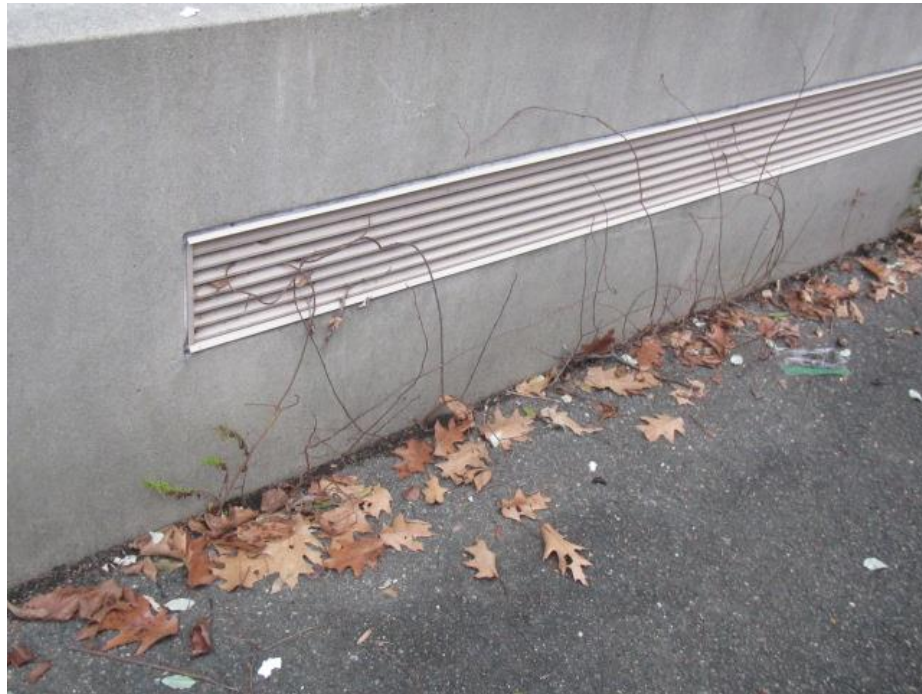
**Picture 25**

**Plant growth along seam of concrete foundation and tarmac**

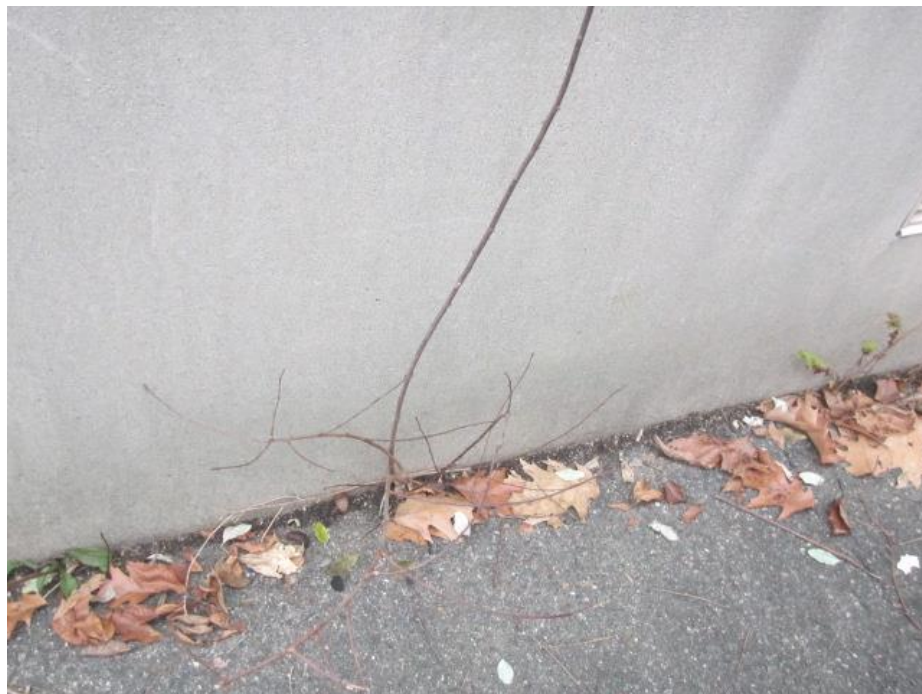
**Picture 26**

**Plant growth along seam of concrete foundation and tarmac**

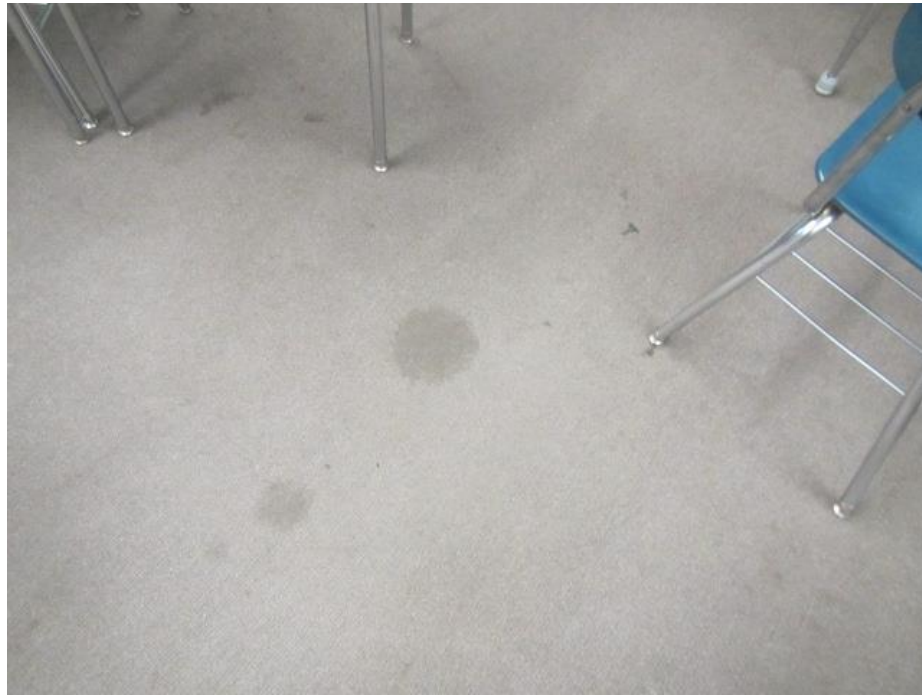
Picture 27

- Reporting pest sightings or new gaps in the building envelope to facility management.
- **Some areas are covered with wall-to-wall carpet that is soiled/stained and past its service life (Picture 27).** Carpeting has a service life of approximately 10-11 years (IICRC, 2002). Carpeting that is beyond its service life becomes increasingly difficult to clean and may release fibers which can be irritating if airborne. Carpets should be vacuumed regularly with a high efficiency particulate arrestance (HEPA) filter equipped vacuum cleaner and cleaned annually (or semi-annually in soiled/high traffic areas) in accordance with Institute of Inspection, Cleaning and Restoration Certification (IICRC) recommendations (IICRC, 2012).

Old/soiled carpeting in classroom

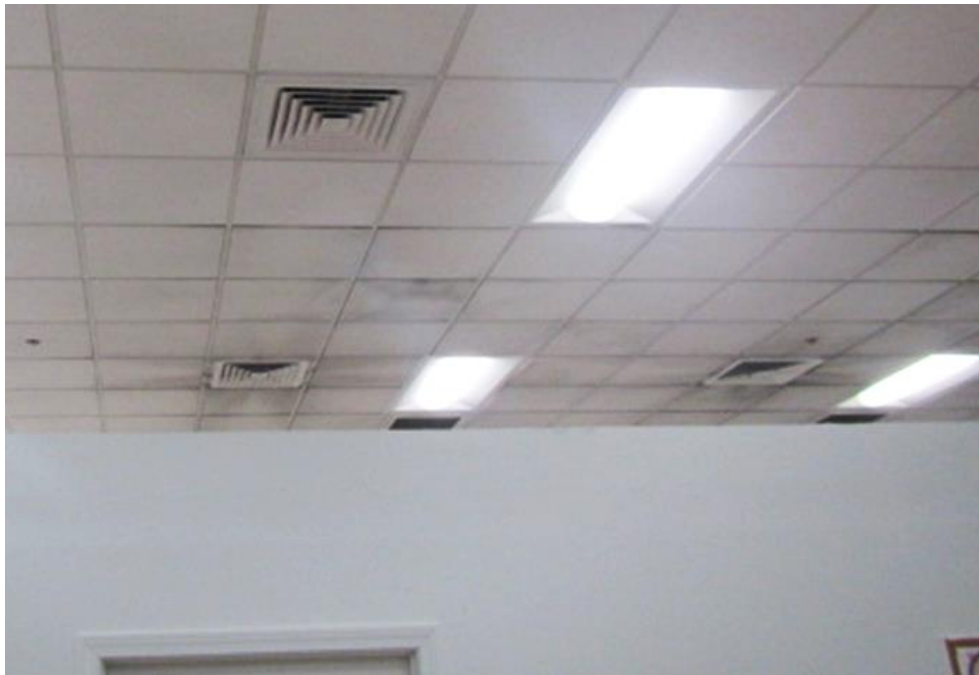
Picture 28

- **Supply, exhaust, return vents and surrounding ceiling tiles had accumulations of dust and debris (Table 1, Picture 28).** This dust/debris can be aerosolized under certain conditions, and should be cleaned periodically (e.g., during regular filter changes). It is important to note that the location of these tiles *directly in the airstream* of mechanical ventilation makes them more susceptible to collecting dust due to constant airflow over the surface of the tile. If these tiles cannot be adequately cleaned, they should be replaced.

Accumulated dust and debris on vents and surrounding ceiling tiles

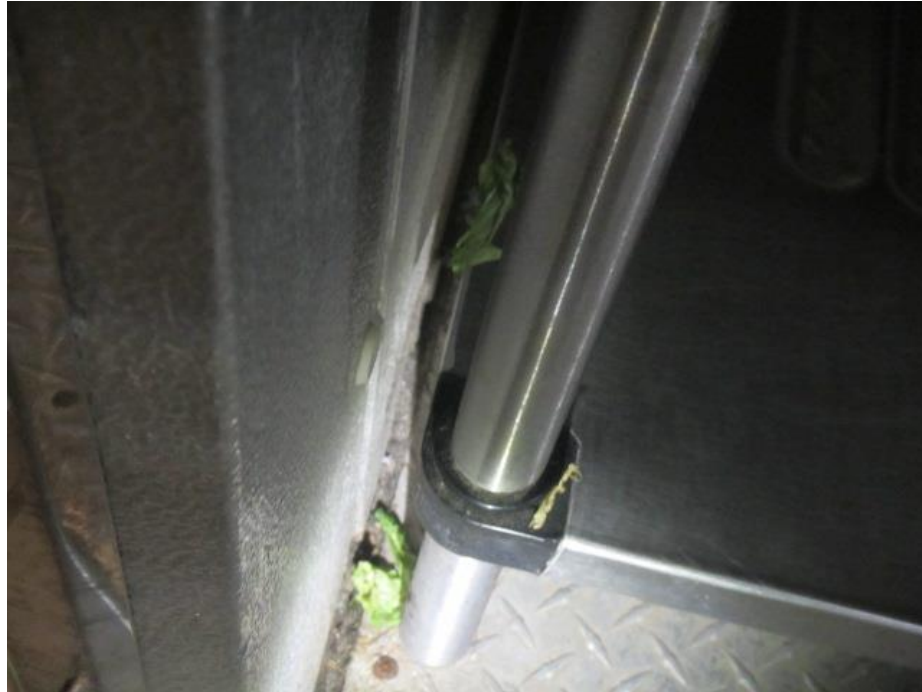
Picture 29

- A walkthrough of the kitchen area was conducted, and **food was noted along the floor of the walk-in refrigerator and freezer (Pictures 29 and 30).** In addition, condensation was noted dripping from the ceiling of the walk-in freezer (Picture 31).

Food (lettuce) on floor of walk-in refrigerator

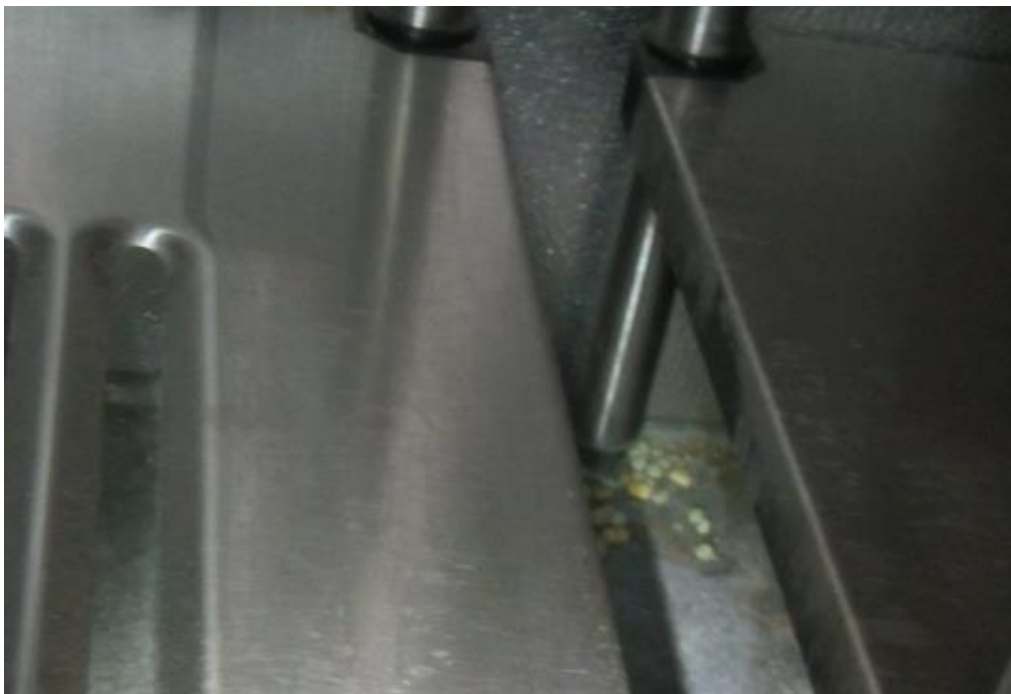
Picture 30

Food (lettuce) on floor of walk-in refrigerator/freezer

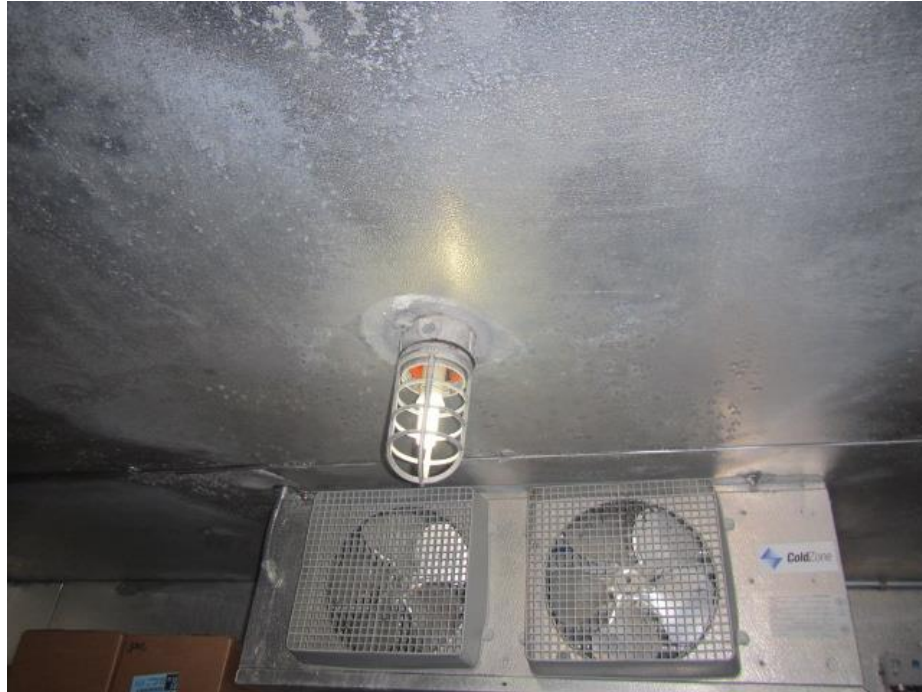
Picture 31

Condensation on ceiling of walk-in freezer

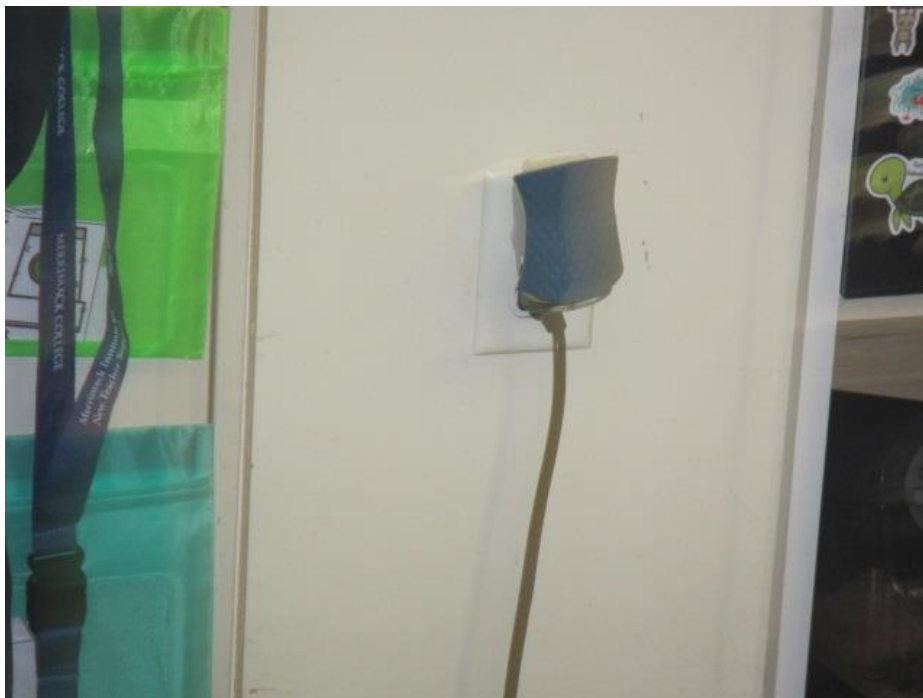
Picture 32

Plug-in air freshener in classroom
