# Timony Grammar School

## City of Methuen ADA Transition Plan

October 2024

Institute for Human Centered Design

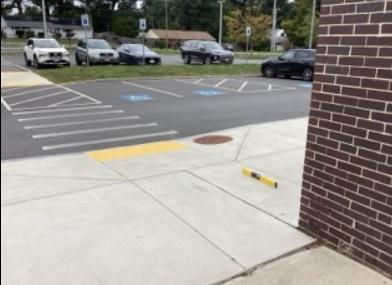
ID	Location	Floor	Room	Element	Type	Photo	Issues	Current Measure	Recommendations	Quantity	Price	Cost Estimation
6	Route by Southwest Drop Off	Ext.		Curb Ramp	Blended Transition

Running slope at landing > 1:50 (2.00%)	3%	Reduce the running slope at the curb ramp landing to be no steeper than 1:50 (2.00%).	1	-	-
<b>Off-Street Parking Lot or Garage</b>												
7	Accessible Parking Outside of Gymnasium	Ext.		Off-Street Parking Lot or Garage	Visitor

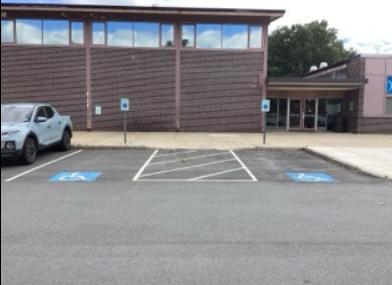
Running or cross slope at access aisle > 1:50 (2.00%) Sign does not have the designation "Van Accessible" Sign bottom < 60" above finished grade	3% - 52"	Reduce running or cross slope to be no steeper than 1:50 (2.00%). Add the designation "Van Accessible" to the sign located at the van accessible space. Locate sign with the bottom of the sign 60" min. above the ground measured to the bottom of the sign, and 96" max. above the ground measured to the top of the sign. Cost is for signage.	1	- 500 Labor  <b>500</b>	\$500

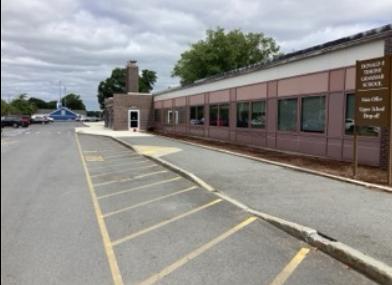
Sign with ISA not provided (MAAB)	-	Provide a sign that includes the International Symbol of Accessibility (ISA) at the head of the space. Locate the sign so that the bottom is 60" min. above the ground and the top is 96" max. above the ground.	1	500  <b>500</b>	\$500
<b>Access to Goods and Services</b>

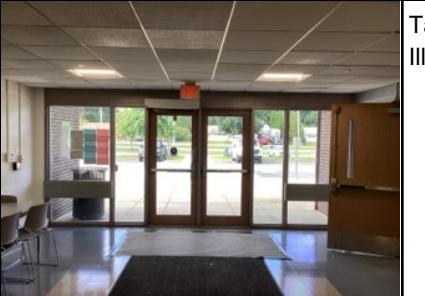
ID	Location	Floor	Room	Element	Type	Photo	Issues	Current Measure	Recommendations	Quantity	Price	Cost Estimation
<b>Means of Egress</b>												
10	Main Entrance and Egress	1		Means of Egress	N/A

Tactile exit sign not provided Illuminated ISA symbol not provided (MAAB)	- -	Ensure that a tactile exit sign with raised characters and braille is provided at the exit door. Mount the sign between 48"- 60" above the finished floor located on the right side of the right door. When the illuminated exit sign is repaired or replaced, provide an illuminated sign with the International Symbol of Accessibility (ISA).	1	250	\$250
<b>Interior Access Route</b>												
11	Defibrillator Across From Men's and Women's Single-User Toilet Rooms	1		Interior Access Route	N/A

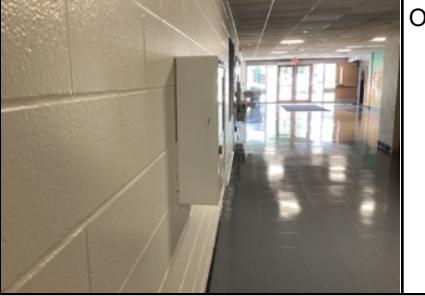
Obstructed by protruding objects	6"	Provide a cane-detectable barrier underneath the defibrillator. Barriers must have leading edges no higher than 27" so that they are within cane sweep. Barriers can include fixed planters, benches, and guardrails.	1	398	\$398

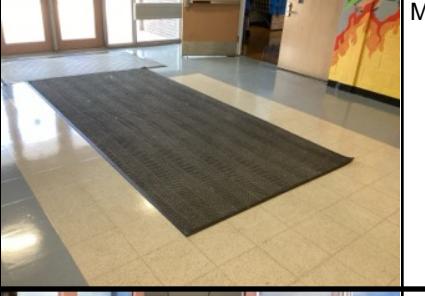
<b>Doors, Doorways, &amp; Gates</b>												
12	Main Entrance and Egress	1		Doors, Doorways, & Gates	Circulation

Mat not securely attached	-	Secure the mat.	1	Labor	Labor
13	Main Entrance and Egress by Gymnasium	1		Doors, Doorways, & Gates	Circulation

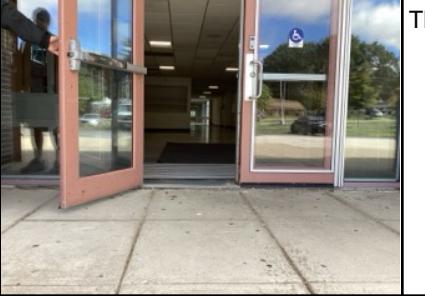
Threshold > 1/2" high	1"	Alter the threshold to be 1/2" high max.	1	1000	\$1000
14	Egress From Playground in Southwest School Courtyard	Ext.		Doors, Doorways, & Gates	Circulation

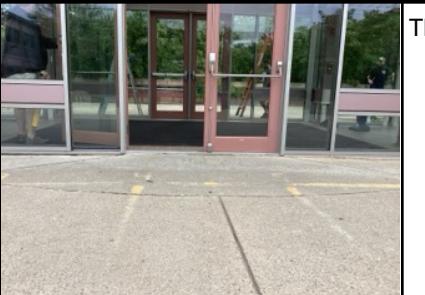
Threshold > 1/2" high	1.5"	Alter the threshold to be 1/2" high max.	1	1000	\$1000

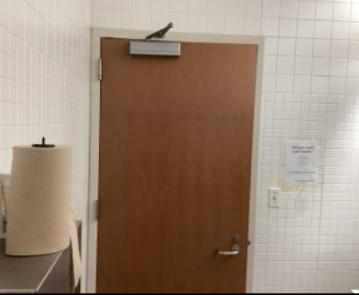
ID	Location	Floor	Room	Element	Type	Photo	Issues	Current Measure	Recommendations	Quantity	Price	Cost Estimation
15	Men's Accessible Single-User Toilet Room	1		Doors, Doorways, & Gates	Toilet Room

Door requires > 5 lbs. of force to open	16 lbs	Adjust closers so doors do not require more than 5 pounds of force to open.  Applies to all doors in this condition.	1	Labor	Labor
<b>Signage</b>												
16	Men's Multi-User Toilet Rooms	1		Signage	Designation

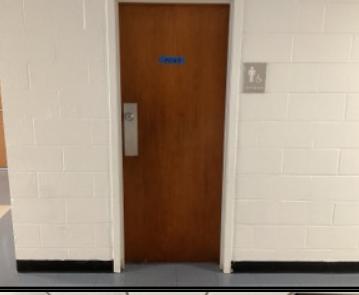
Location of tactile sign not compliant	-	Locate sign alongside the door on the latch side.	1	Labor	Labor
17	Entrance to Gymnasium	1		Signage	Designation

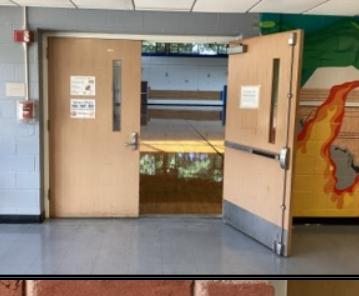
Location of tactile sign not compliant	-	Where a tactile sign is provided at double door with two active leafs, locate the sign to the right of the right-hand door.	1	Labor	Labor
18	Men's and Women's Single-User Toilet Rooms	1		Signage	Designation

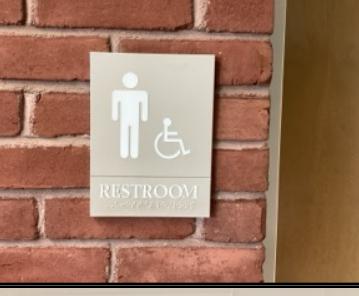
Character style not compliant	-	Provide a sign with compliant characters. Characters should be sans serif.	2	250	\$500

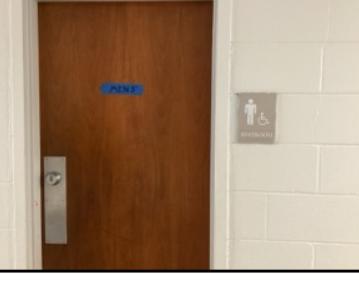
19	Men's and Women's Multi-User Toilet Rooms	1		Signage	Designation

Character style not compliant	-	Provide a sign with compliant characters. Characters should be sans serif.	2	250	\$500

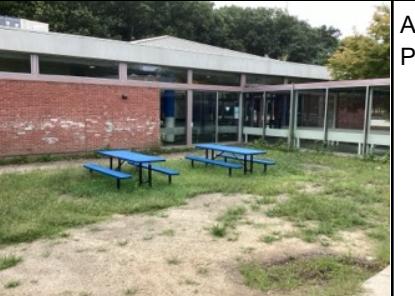
ID	Location	Floor	Room	Element	Type	Photo	Issues	Current Measure	Recommendations	Quantity	Price	Cost Estimation
<b>Picnic Tables</b>												
20	Playground in Southwest School Courtyard	Ext.		Picnic Tables	N/A

At least 5% accessible spaces not provided Picnic table not on an accessible route	- -	Ensure that at least 5% (minimum one) of picnic tables are accessible. Ensure that the accessible picnic table is connected to an accessible route.	1	1400	\$1400
<b>Toilet &amp; Bathing Rooms</b>												
<b>Overall Access</b>												
21	Men's and Women's Multi-User Toilet Rooms	1		Overall Access	Toilet Room

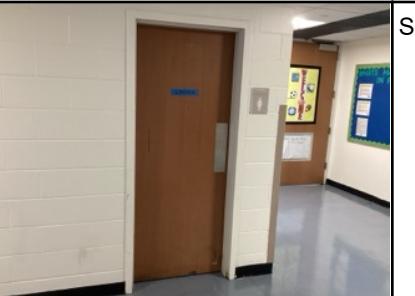
Sign to accessible toilet not provided	-	Provide a directional sign indicating the location of the nearest accessible toilet or bathing room.	2	250	\$500
<b>Single-User Toilet</b>												
22	Women's Single-User Toilet Room	1		Single-User Toilet	N/A

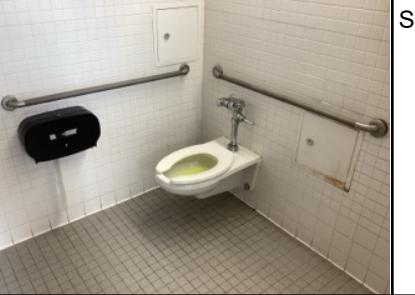
Side grab bar < 54" from back wall	48"	Provide a side wall grab bar that is 42" long min. located 12" max. from the rear wall.	1	750	\$750

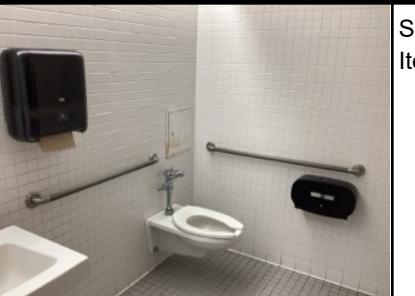
23	Men's Single-User Toilet Room	1		Single-User Toilet	N/A

Side grab bar < 54" from back wall Item mounted over grab bar (MAAB)	48" -	Provide a side wall grab bar that is 42" long min. located 12" max. from the rear wall. Relocate paper towel dispenser so that it is not mounted over the grab bar.	1	750 500	\$1250 1250

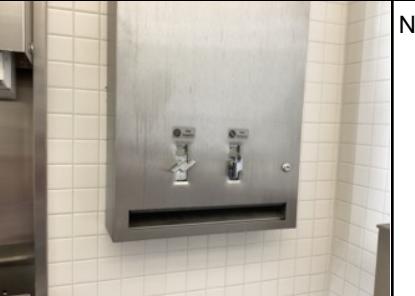
ID	Location	Floor	Room	Element	Type	Photo	Issues	Current Measure	Recommendations	Quantity	Price	Cost Estimation
<b>Dispensers</b>												
24	Women's Single-User Toilet Room	1		Dispensers	Tampon Dispenser

Noncompliant operable part	-	Provide a tampon dispenser that can be operable with one hand and not require tight grasping, pinching, or twisting of the wrist.	1	1000	\$1000
											1000	
25	Women's Single-User Toilet Room	1		Dispensers	Paper Towel Dispenser

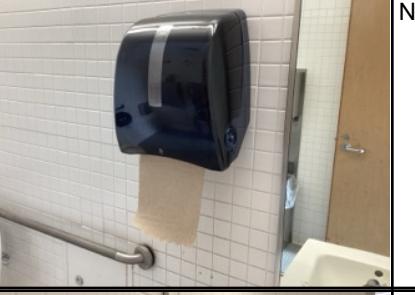
Noncompliant operable part	-	Provide a paper towel dispenser that can be operable with one hand and not require tight grasping, pinching, or twisting of the wrist.	1	200	\$200
											200	
26	Women's Single-User Toilet Room	1		Dispensers	Paper Towel Dispenser

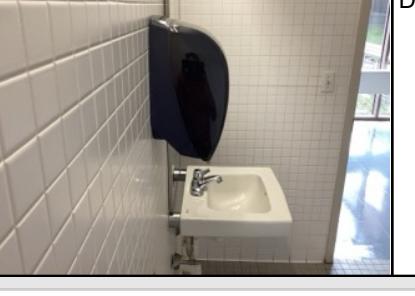
Dispenser acts as a protruding object	9"	When a new paper towel dispenser is provided, locate the dispenser next to the lavatory, on the wall adjacent to the lavatory.	1	Labor	Labor

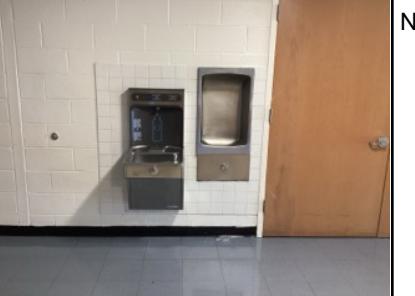
<b>Additional Access</b>												
<b>Drinking Fountains</b>												
27	Drinking Fountains by Gymnasium	1		Drinking Fountains	Low

No drinking fountain provided for standing users	-	Repair the existing standing height drinking fountain or provide a new standing height drinking fountain.	1	4028	\$4028
												4028
<b>Play and Sport Areas</b>

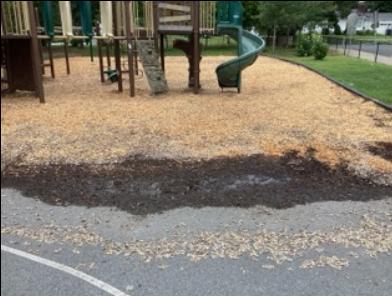
ID	Location	Floor	Room	Element	Type	Photo	Issues	Current Measure	Recommendations	Quantity	Price	Cost Estimation
<b>Play Areas</b>												
28	Southwest Playground	Ext.		Play Areas	N/A

Accessible route does not prevent accumulation of water	-	Repair the accessible route to the playground so that it does not accumulate water.	1	-	-
29	Playground in Southwest School Courtyard	Ext.		Play Areas	N/A

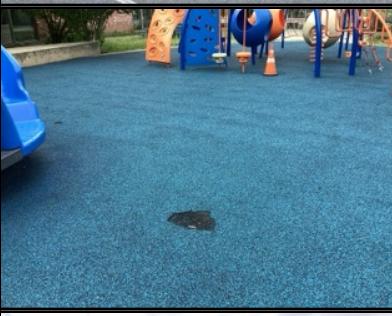
Surface not maintained in operable working condition	-	Repair areas where level changes are present due to deteriorated areas on the play area surface.	1	-	-
30	Playground in Southwest School Courtyard	Ext.		Play Areas	N/A

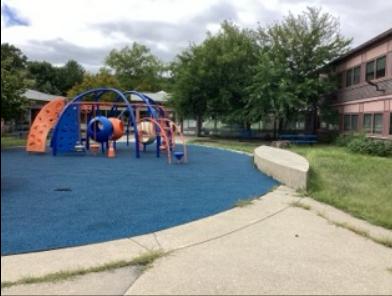
Accessible route not provided around playground	-	Provide a 48" wide min. stable, firm and slip resistant compliant accessible route around the play area.	1	-	-
31	Southwest Playground	Ext.		Play Areas	N/A

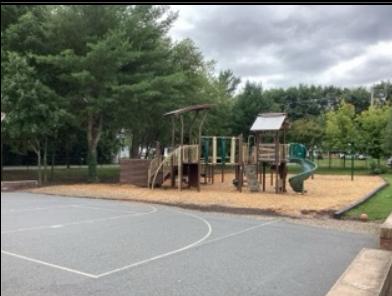
Accessible route not provided around playground Accessible route not provided to play components	- -	Provide a 48" wide min. stable, firm and slip resistant compliant accessible route around the play area. Provide a compliant impact-attenuating surface to and around the play components.	1	-	-

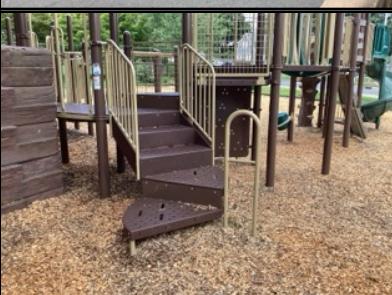
32	Southwest Playground	Ext.		Play Areas	N/A

No compliant transfer system	7.5"	Ensure the top surface of the transfer platform is between 11 and 18 inches high, measured from the ground.	1	-	-

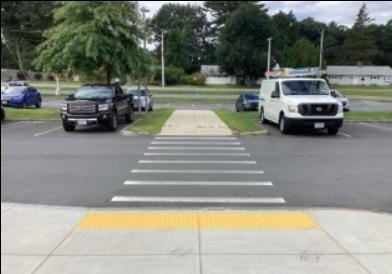
ID	Location	Floor	Room	Element	Type	Photo	Issues	Current Measure	Recommendations	Quantity	Price	Cost Estimation
Cross Walk												
33	Crosswalk to Main Entrance and Egress by Gymnasium

If a detectable warning platform is provided on only one side of a cross walk, recommend providing a detectable warning platform on both sides of the crosswalk.	1	-	-
Social Steps												
34	Social Steps at Playground by Lower School Drop Off

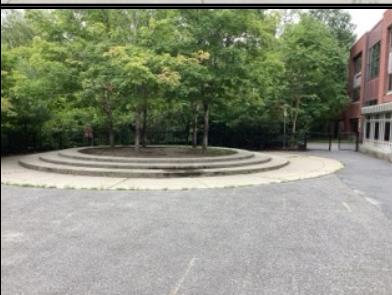
Recommend providing a 36" min. by 48" min. stable, firm and slip-resistant surface adjacent to at least one area within these social steps, positioned to allow a person in a wheeled mobility device and a person sitting on the bench to have their shoulders aligned.	1	-	-
Cross Walk												
35	Accessible Parking Outside of Gymnasium	Ext.		Cross Walk	N/A

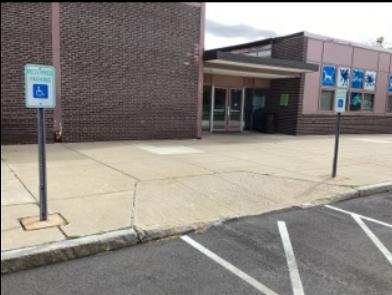
Recommend, since other cross walks in this parking area have detectable warnings, providing detectable warnings at both ends of this cross walk and ensuring that they are provided at all cross walks on the school grounds.	1	Labor	Labor
