Methuen Senior Activity Center

City of Methuen ADA Transition Plan

August 2024

Methuen Senior Activity Center is located at 77 Lowell Street. The building contains a basement and first floor, which are connected by stairs and an elevator.

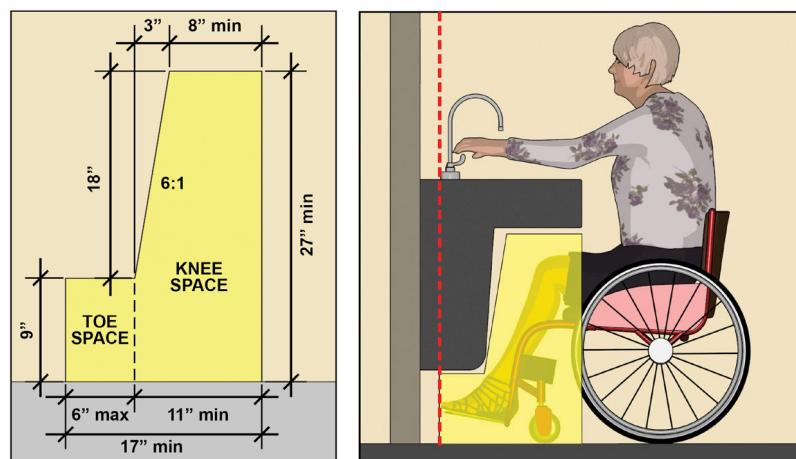
Accessibility issues include lack of toe and knee clearances at sinks and sinks located higher than allowed. See the following diagrams from the U.S. Access Board showing accessible knee and toe clearance at a sink:

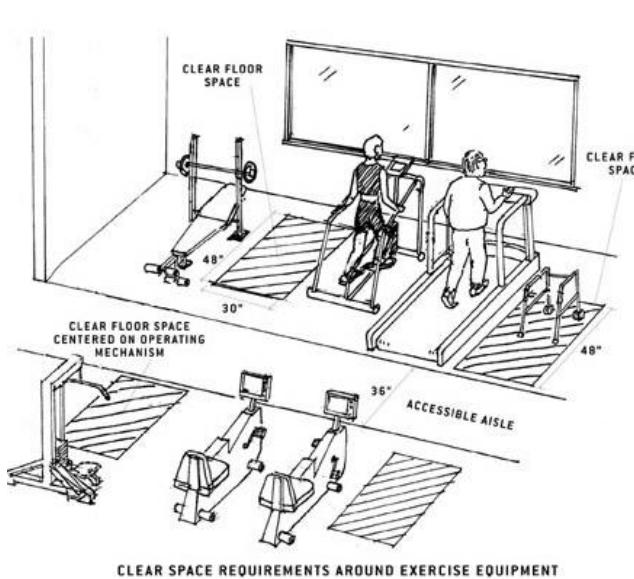
The following image, from the U.S. Access Board, illustrates how gym equipment can be positioned to ensure an accessible route and clear floor space allowing for transfer by at least one of each unique type of gym apparatus.

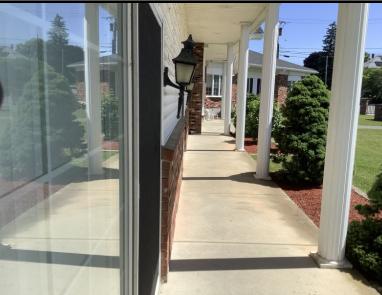
Obstructed by protruding objects	5"	Provide a cane-detectable barrier under the light or provide a light fixture with a narrower profile. (Cost estimate is for a cane-detectable barrier.)	1	398	\$398
2	Path From Rt. 113 Sidewalk to Front Entrance (South/East Door)	Ext.	-	Exterior Access Route	Walkway

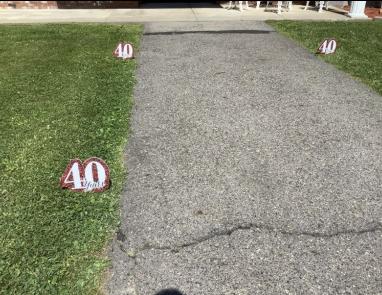
Surface openings > 1/2" Route not maintained in operable working condition	1" -	Ensure that the surface opening is no greater than 1/2" max. Ensure the accessible route is maintained in operable working condition.	1	-	-
3	Sidewalk on Barker Street (North/East Border of Site)	Ext.	-	Exterior Access Route	Sidewalk

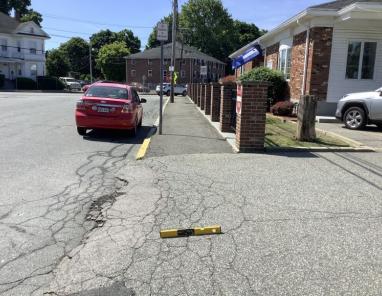
Cross slope > 1:50 (2.00%)	5.9%	Reduce cross slope to be no steeper than 1:50 (2.00%).	1	-	-

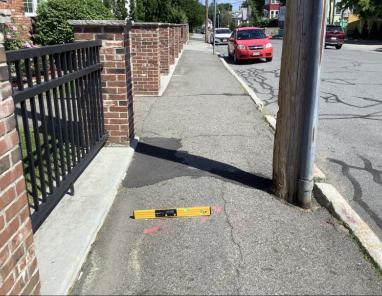
4	Sidewalk on Barker Street (North/East Border of Site)	Ext.	-	Exterior Access Route	Sidewalk

Cross slope > 1:50 (2.00%)	5.6%	Reduce cross slope to be no steeper than 1:50 (2.00%).	1	-	-
5	Sidewalk on Rt. 113 (South/East Border of Site)	Ext.	-	Exterior Access Route	Sidewalk

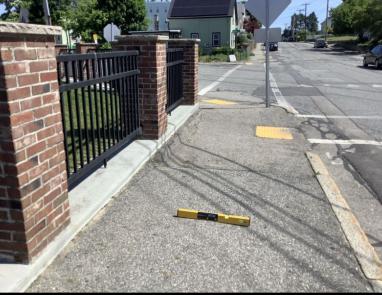
Cross slope > 1:50 (2.00%)	6.8%	Reduce cross slope to be no steeper than 1:50 (2.00%).	1	-	-

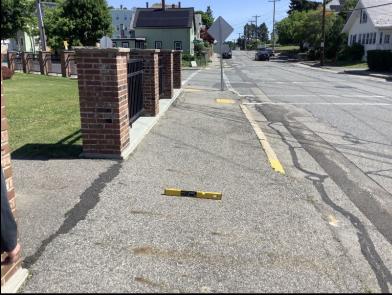
Cross slope > 1:50 (2.00%)	4.9%	Reduce cross slope to be no steeper than 1:50 (2.00%).	1	-	-
7	School Street Sidewalk (South/West Border of Site)	Ext.	-	Exterior Access Route	Sidewalk

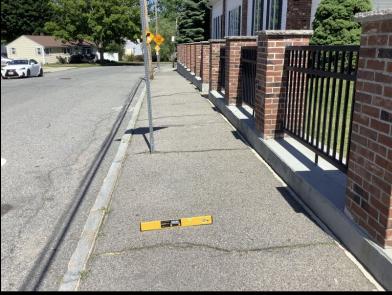
Cross slope > 1:50 (2.00%)	7.6%	Reduce cross slope to be no steeper than 1:50 (2.00%).	1	-	-
8	School Street Sidewalk (South/West Border of Site)	Ext.	-	Exterior Access Route	Sidewalk

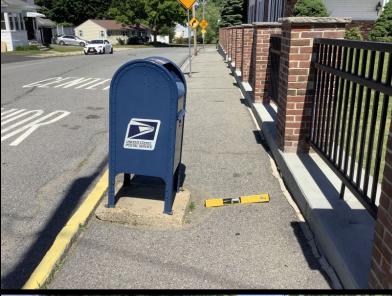
Cross slope > 1:50 (2.00%)	15%	Reduce cross slope to be no steeper than 1:50 (2.00%).	1	-	-
9	School Street Sidewalk (South/West Border of Site)	Ext.	-	Exterior Access Route	Sidewalk

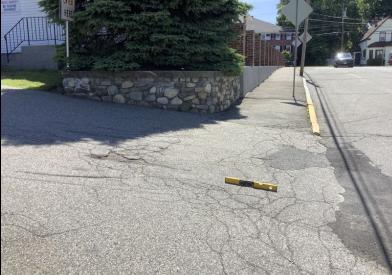
Cross slope > 1:50 (2.00%)	11.8%	Reduce cross slope to be no steeper than 1:50 (2.00%).	1	-	-
10	Path From Rt. 113 Sidewalk to Front Entrance (South/East Door)	Ext.	-	Exterior Access Route	Walkway

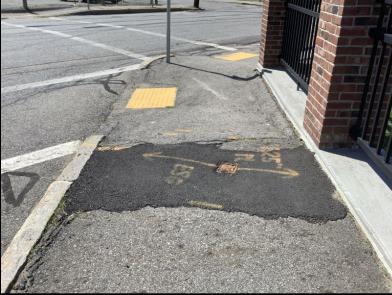
Route not maintained in operable working condition	-	Ensure the accessible route is maintained in operable working condition.	1	-	-
12	School Street Sidewalk (South/West Border of Site)	Ext.	-	Exterior Access Route	Sidewalk

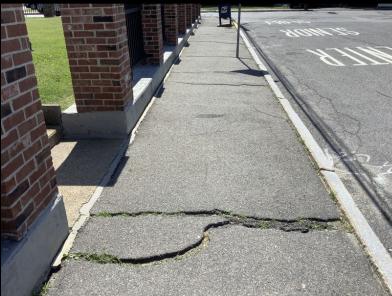
Surface openings > 1/2" Route not maintained in operable working condition	7" -	Ensure that the surface opening is no greater than 1/2" max. Ensure the accessible route is maintained in operable working condition.	1	-	-
Curb Ramp												
13	Sidewalk on Corner of Barker Street and Rt. 113	Ext.	-	Curb Ramp	Diagonal

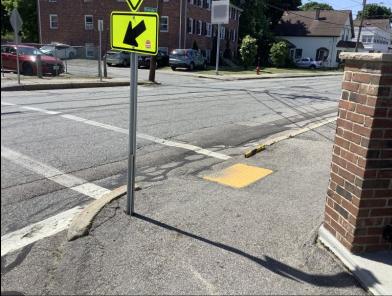
Curb ramp flares > 1:10 (10%)	12.3%	Reduce slope at curb ramp flares to be no steeper than 1:10 (10%). Applies to both flares.	2	-	-
Off-Street Parking Lot or Garage

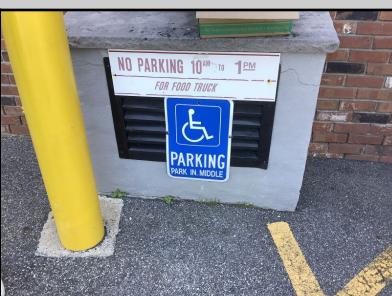
14	Accessible Parking by Back Entrance	Ext.	-	Off-Street Parking Lot or Garage	Visitor

Sign bottom < 60" above finished grade	6.5"	Locate sign with the bottom of the sign 60" above the ground.	1	Labor	Labor
15	Accessible Parking by Back Entrance	Ext.	-	Off-Street Parking Lot or Garage	Visitor

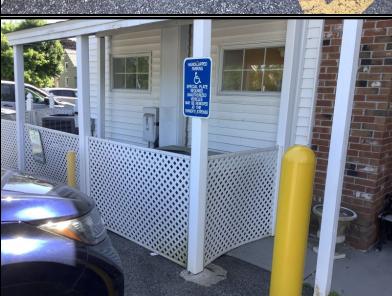
Sign bottom < 60" above finished grade	53"	Locate sign with the bottom of the sign 60" above the ground.	1	Labor	Labor

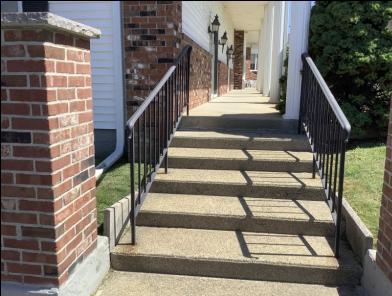
Handrails do not extend 12" from stair at top Bottom handrail extends < 12" + one tread Cross section of handrail is not compliant	0" 0" -	Replace the rails; ensure new rails provide handrails that extend horizontally above the landing for 12" min. beginning above the first riser nosing, have sloped bottom handrail extensions that extend one tread depth min. beyond last riser nosing in same direction as stair flight, and provide handrails with 1 1/4" - 2" circular cross sections.	1	-	-
17	Egress Door Leading to Barker Street Sidewalk (East)	Ext.	-	Exterior Stair	N/A

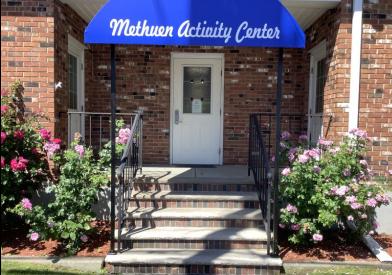
Bottom handrail extends < 12" + one tread Cross section of handrail is not compliant	0" -	Replace the rails; ensure new rails have sloped bottom extensions that extend one tread depth min. beyond last riser nosing in same direction as stair flight, and provide handrails with 1 1/4" - 2" circular cross sections.	1	-	-

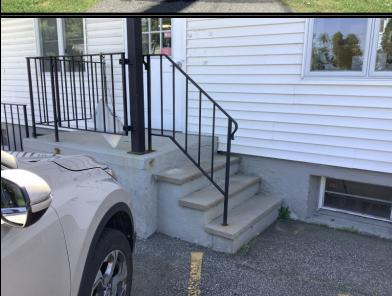
Handrail height < 34" or > 38" Bottom handrail extends < 12" + one tread Cross section of handrail is not compliant Handrail not provided on both sides	39" 0" - -	Alter so the handrails are 34"- 38" high above the finished floor or ground. Bottom: Ensure that the sloped bottom extension extends one tread depth min. beyond last riser nosing in same direction as stair flight. Provide handrails with 1 1/4" - 2" circular cross sections. Provide a handrail on each side.	1	-	-
19	North Emergency Egress Stair	B	-	Exterior Stair	N/A

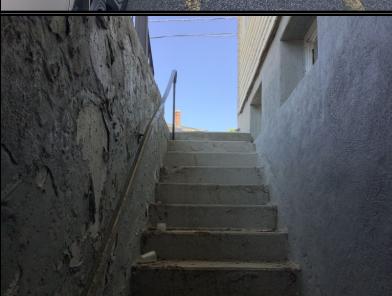
Handrails do not extend 12" from stair at top Bottom handrail extends < 12" + one tread Cross section of handrail is not compliant Handrail not provided on both sides Surface not stable, firm, and slip-resistant Handrail not maintained in operable working condition	0" 0" - - - -	Ensure handrails extend horizontally above the landing for 12" min. beginning above the first riser nosing. Ensure that the sloped bottom extension extends one tread depth min. beyond last riser nosing in same direction as stair flight. Provide handrails with 1 1/4" - 2" circular cross sections. Provide a handrail on each side. Ensure that the surface is cleared of debris. Ensure the handrail is maintained.	1	-	-

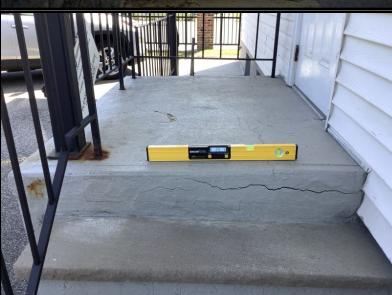
Not maintained in operable working condition		Ensure stairs are maintained in operable working condition. The cross slope at the landing is 2.6%.	1	-	-

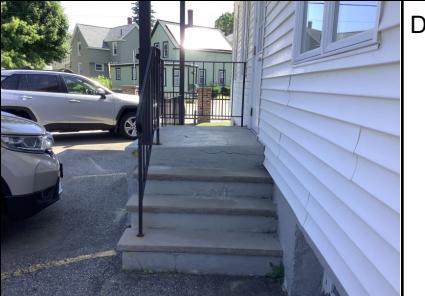
Directional sign to accessible entrance not provided	-	Provide a directional sign indicating the location of the nearest accessible entrance.	1	450	\$450
											450	
22	Egress Door Leading to Barker Street Sidewalk (East)	Ext.	-	Entrance	Secondary Entrance

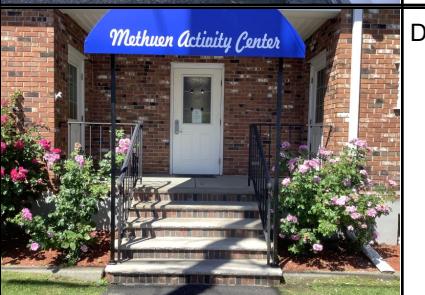
Directional sign to accessible entrance not provided	-	Provide a directional sign indicating the location of the nearest accessible entrance at the bottom corner of the staircase. Applies to both sliding doors at the auditorium.	3	450	\$1350
											1350	
23	Back Entrance (North Side of Building) Applies to South/East Front Entrance	Ext.	-	Entrance	Main Entrance

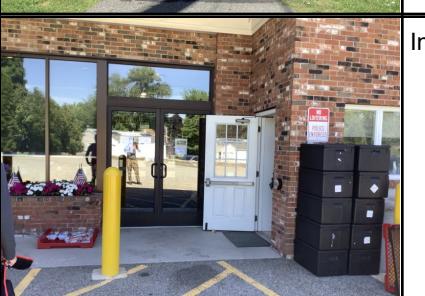
International Symbol of Accessibility not provided	-	Provide a sign with the International Symbol of Accessibility (ISA).	2	450	\$900

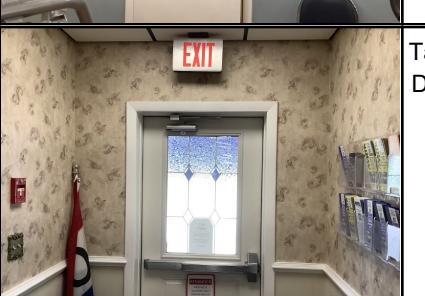
Tactile exit sign not provided Directional sign to accessible emergency exit not provided	-	Ensure that a tactile exit sign with raised characters and braille is provided at the exit door. Mount the sign between 48"- 60" above the finished floor located on the latch side of the door. Provide a directional sign indicating the location of the nearest accessible emergency exit.	6	250 250	\$3000

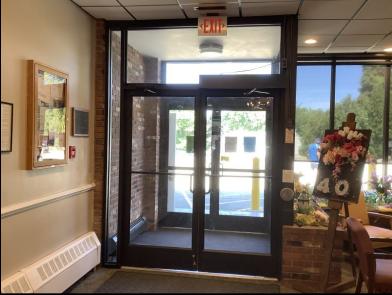
Tactile exit sign not provided Illuminated ISA symbol not provided (MAAB)	- -	Ensure that a tactile exit sign with raised characters and braille is provided at the exit door. Mount the sign between 48"- 60" above the finished floor located on the right side of the double doors. When the illuminated sign is replaced, provide an illuminated sign with the International Symbol of Accessibility (ISA).	2	250	\$500
Interior Access Route												
27	Nurse's Office Inside Clinic	1	-	Interior Access Route	N/A

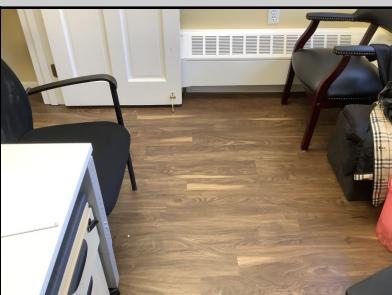
Ensure the chair next to door is moved if a wheelchair user is to enter into the office.	1	Labor	Labor
28	Classroom 1	1	-	Interior Access Route	N/A

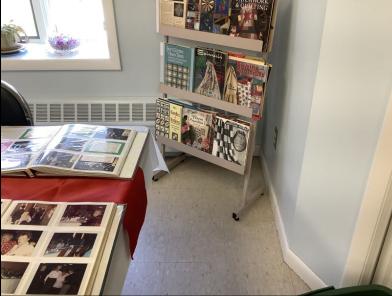
Route < 36" wide	25"	Ensure that a clear width of 36" min. is maintained at the accessible route. Relocate furniture.	1	Labor	Labor

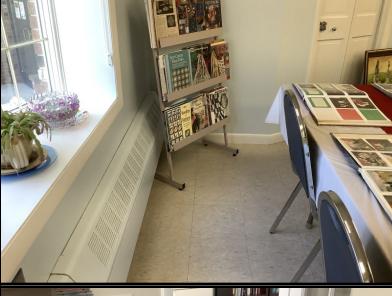
29	Classroom 1	1	-	Interior Access Route	N/A

Route < 36" wide	30"	Ensure that a clear width of 36" min. is maintained at the accessible route. Relocate furniture.	1	Labor	Labor
30	Thrift Store	1	-	Interior Access Route	N/A

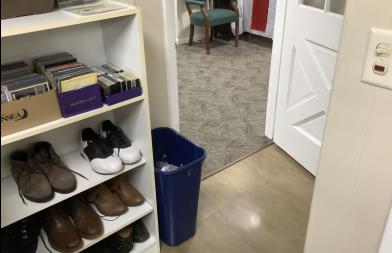
Route < 36" wide	28.5"	Ensure that a clear width of 36" min. is maintained at the accessible route. Move shelf and trash can over.	1	Labor	Labor

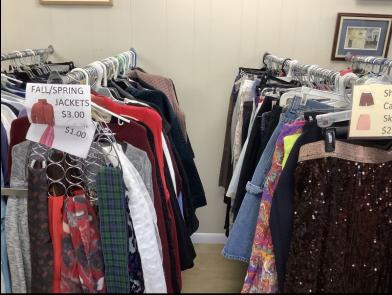
Route < 36" wide	11.5"	Ensure that a clear width of 36" min. is maintained at the accessible route. Applies to all aisles in the thrift store.	1	Labor	Labor
32	Meeting Space	B	-	Interior Access Route	N/A

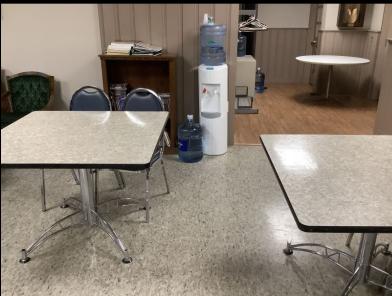
Route < 36" wide	25"	Ensure that a clear width of 36" min. is maintained at the accessible route. Relocate furniture.	1	Labor	Labor
33	Main Lobby	1	-	Interior Access Route	N/A

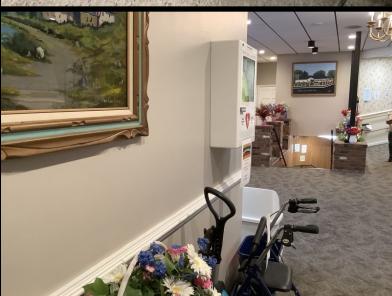
Obstructed by protruding objects	5"	Provide a cane-detectable barrier under the defibrillator.	1	398	\$398
34	Auditorium/ Dining Space	1	-	Interior Access Route	N/A

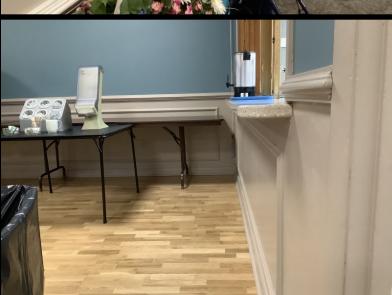
Obstructed by protruding objects	6"	Provide a cane-detectable barrier on each side of the counter. Barriers must have leading edges no higher than 27" so that they are within cane sweep. Barriers can include fixed planters, benches, and guardrails.	2	398	\$796

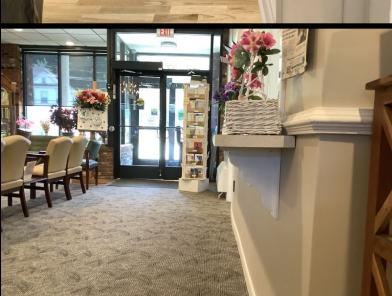
Obstructed by protruding objects	5"	Provide a cane-detectable barrier on each side of the counter. Barriers must have leading edges no higher than 27" so that they are within cane sweep. Barriers can include fixed planters, benches, and guardrails.	2	398	\$796

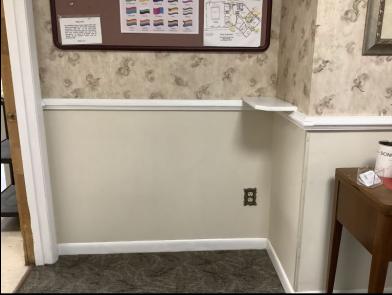
Obstructed by protruding objects	7"	If this shelf is not often used, recommend removing it. Otherwise provide a cane-detectable barrier.	1	398	\$398
											398	
37	Classroom 2, Classroom 1, Classroom 3, Nurse Clinic, and Thrift Shop	1	-	Interior Access Route	N/A

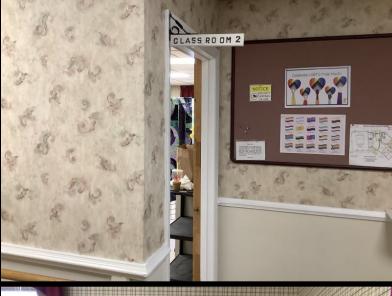
Obstructed by protruding objects	15"	Ensure that objects, such as signs, are located no lower than 80" above the finished floor.	5	Labor	Labor
38	Classroom 2	1	-	Interior Access Route	N/A

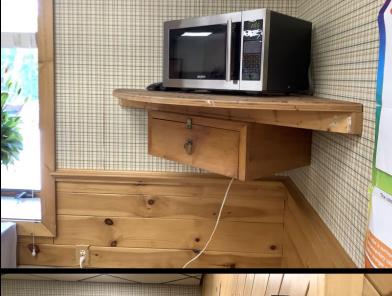
Obstructed by protruding objects	7"	Provide a cane-detectable barrier under the microwave.	1	398	\$398
											398	
39	Classroom 2	1	-	Interior Access Route	N/A

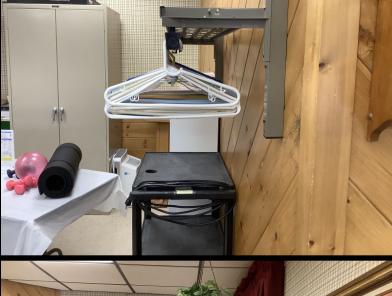
Obstructed by protruding objects	12"	Provide a cane-detectable barrier at the open end of the clothes rack.	1	398	\$398

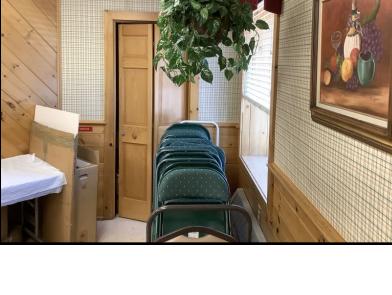
Obstructed by protruding objects	69.5"	Relocate the plant.	1	Labor	Labor

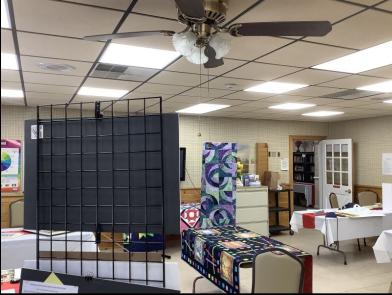
Obstructed by protruding objects	-	Relocate the pull string so that it is no lower than 80" above the finished floor. Applies to all ceiling fans in classrooms and corridors.	1	Labor	Labor
42	Thrift Store	1	-	Interior Access Route	N/A

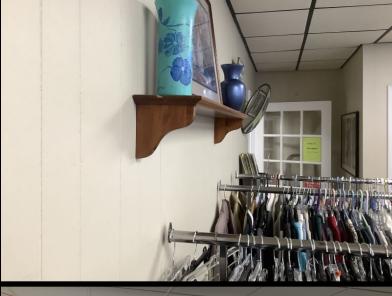
Obstructed by protruding objects	7"	Relocate shelf.	1	Labor	Labor
43	Game Room	B	-	Interior Access Route	N/A

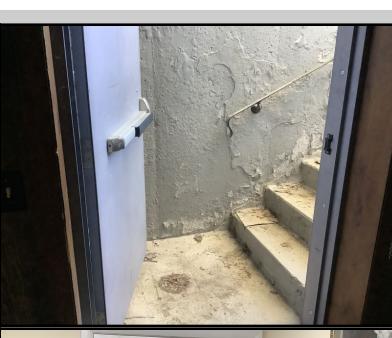
Door gets caught on surface and does not fully open	-	Ensure the surface is maintained in operable working condition for the door to be able to fully open.	1	Labor	Labor
45	Women's Multi-User Toilet Room	1	-	Doors, Doorways, & Gates	Toilet Room

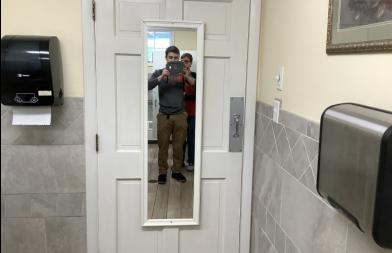
Maneuvering clearance(s) not provided	3.5"	Reverse the latch and the hinge side of the door, and relocate the paper towel dispenser so that there is 18" on the latch side of the door. (Cost is for reversing the door.)	1	2449	\$2449 2449

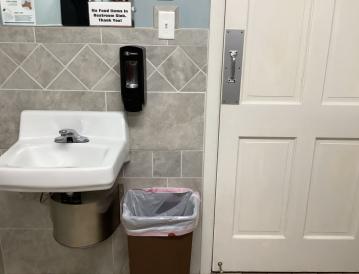
Maneuvering clearance(s) not provided	14"	Move trash can and soap dispenser to provide 18" of maneuvering clearance between the edge of the door and the sink.	1	Labor	Labor
47	Men's Multi-User Toilet Room	1	-	Doors, Doorways, & Gates	Toilet Room

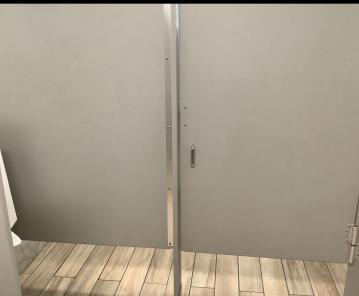
Maneuvering clearance(s) not provided	16.75"	Remove the partition between the urinals to ensure that there is 18" clear on the latch side of the compartment door that is 60" deep.	1	500	\$500
48	Classroom 2	1	--	Doors, Doorways, & Gates	Classroom

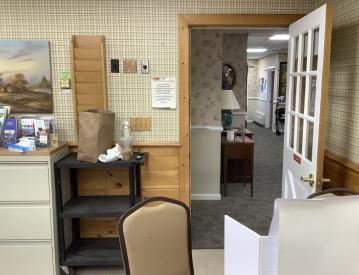
Maneuvering clearance(s) not provided	-	Remove the dolly and ensure that 18" of space on the latch side of the door is kept clear.	1	Labor	Labor
49	Classroom 3	1	-	Doors, Doorways, & Gates	Classroom

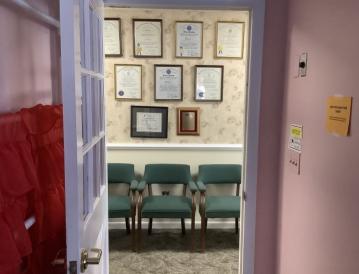
Maneuvering clearance(s) not provided	8.25"	Ensure the programs that take place in Classroom 3 also take place in Classroom 1. Otherwise, an automatic door opener must be provided for Classroom 3.	1	-	-

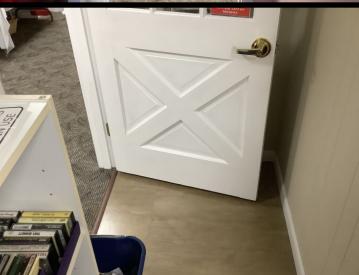
Maneuvering clearance(s) not provided	41" deep	Ensure that the door is propped open during business hours.	1	Labor	Labor

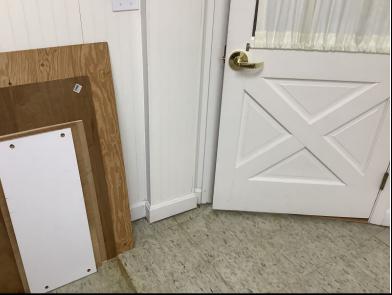
Maneuvering clearance(s) not provided	-	Ensure door is left open during business hours. Otherwise, an automatic door opener will be needed.	1	Labor	Labor
52	Women's and Men's Multi-User Toilet Rooms	B	-	Doors, Doorways, & Gates	Toilet Room

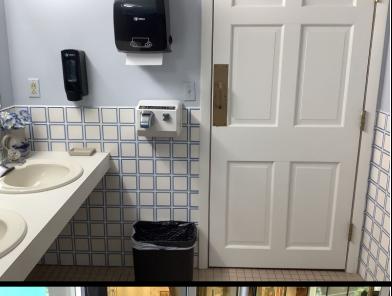
Maneuvering clearance(s) not provided	6"	Move paper towel dispenser to the toilet compartment wall on the other side of the lavatory (urinal partition wall for men's multi-user toilet room) and locate the controls no higher than 48" above the floor. Move the hand dryer above the lavatory so that it does not block the 18" maneuvering clearance on the latch side of the door, and locate the controls no higher than 48" above the floor.	2	500	\$1000 1000
53	Back Entrance (North Side of Building) Applies to South/East Vestibule Entrance	1	-	Doors, Doorways, & Gates	Vestibule

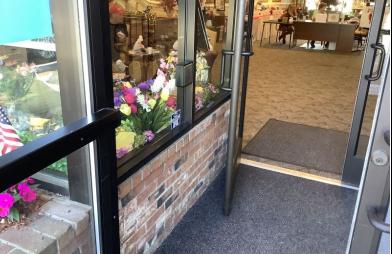
Distance between doors in series < 48" Automatic door opener not operable, door does not open full 90	43"-	Currently the interior automatic door does not open 90 degrees, most likely due to the brick wall. We recommend relocating automatic door openers to the other set of doors in this vestibule where there is more clearance. (Cost estimate is for 2 new automatic door openers.)	2	6000	\$12000 12000

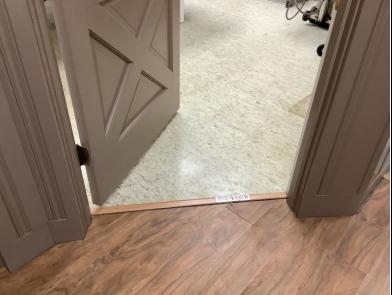
Surface not stable, firm, and slip-resistant at entrance	-	Install new threshold.	1	1000	\$1000 1000
55	Thrift Store	1	-	Doors, Doorways, & Gates	Changing Room

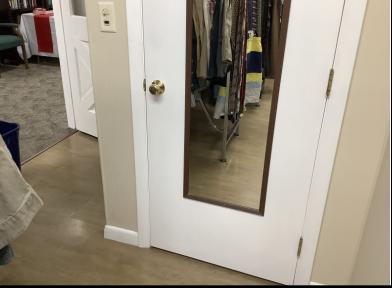
Hardware not compliant	-	Provide hardware that can be operable with one hand and not require tight grasping, pinching, or twisting of the wrist.	1	750	\$750 750

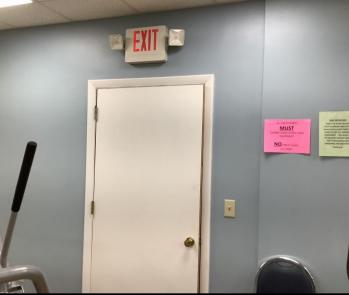
Hardware not compliant	-	Provide hardware that can be operable with one hand and not require tight grasping, pinching, or twisting of the wrist.	1	750	\$750
										750		
57	Women's and Men's Multi-User Toilet Rooms	1	-	Doors, Doorways, & Gates	Toilet Room

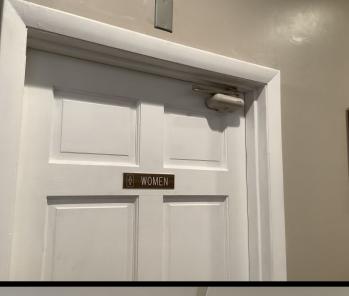
Door requires > 5 lbs. of force to open	9 lbs	Adjust closers so doors do not require more than 5 pounds of force to open.	2	Labor	Labor
58	Men's and Women's Multi-User Toilet Rooms	B	-	Doors, Doorways, & Gates	Toilet Room

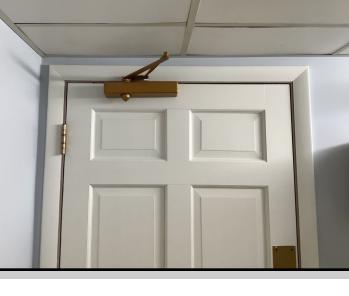
Door requires > 5 lbs. of force to open	8 lbs	Adjust closers so doors do not require more than 5 pounds of force to open.	2	Labor	Labor

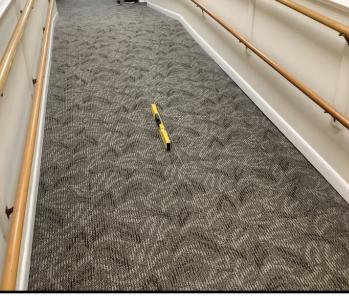
Running slope >1:12 (8.33%)	13.6%	Further study will be needed to determine whether it is technically feasible to bring the ramp into full compliance with the ADA Standards.	1	-	-

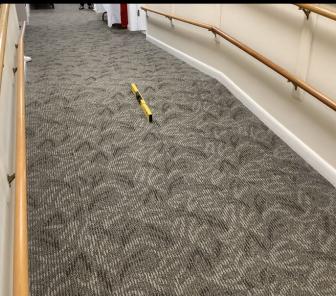
Running slope >1:12 (8.33%)	13.7%	Further study will be needed to determine whether it is technically feasible to bring the ramp into full compliance with the ADA Standards.	1	-	-
62	Main Lobby/ Level 1 Ramp	1	-	Ramps	Interior

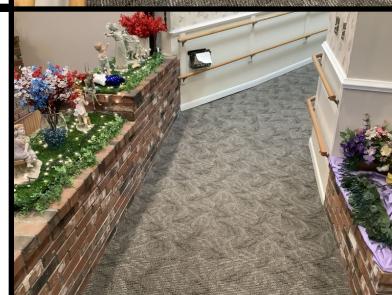
Handrails do not extend 12" past top & bottom	-	Alter handrails to extend horizontally above the landing for 12" min. beyond the top and bottom of ramp runs.	1	-	-
63	Main Lobby/ Level 1 Ramp	1	-	Ramps	Interior

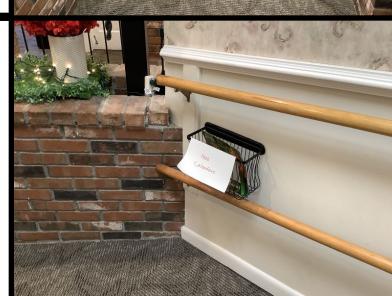
Not maintained in operable working condition	-	Move basket as it is an obstruction to the lower handrail.	1	Labor	Labor
Stairways												
64	Main Lobby/ Main Stairwell	1	-	Stairways	Interior

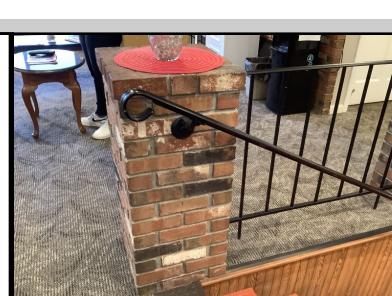
Handrails do not extend 12" from stairs at top Bottom handrail extends < 12" and one tread Handrails lack a compliant cross section	- 0" -	Top: Ensure handrails extend horizontally above the landing for 12" min. beginning above the first riser nosing. Bottom: Ensure that the sloped bottom extension extends one tread depth min. beyond last riser nosing in same direction as stair flight. Provide handrails with 1 1/4" - 2" circular cross sections.	1	-	-

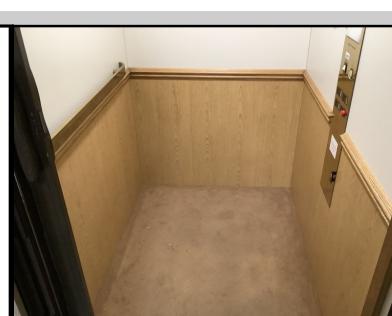
Interior elevator door or gate is not automatic	-	Ensure that the interior elevator door or gate is automatic.	1	Labor	Labor

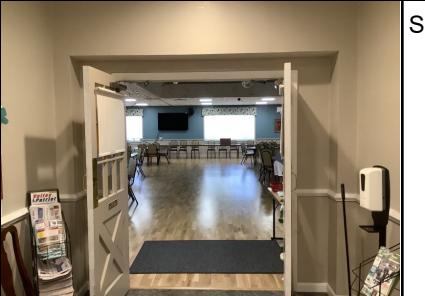
Signage is not provided	-	Locate compliant signage with raised characters and braille alongside the door on the right side of the double doors.	1	250	\$250
											250	
67	Conference Room, Executive Director's Office	1	-	Signage	Designation

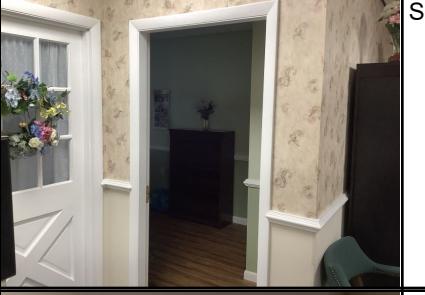
Signage is not provided	-	Locate compliant signage with raised characters and braille alongside the door on the latch side.	2	250	\$500
											500	
68	Game Room, Gym, Ceramics Room	B	-	Signage	Designation

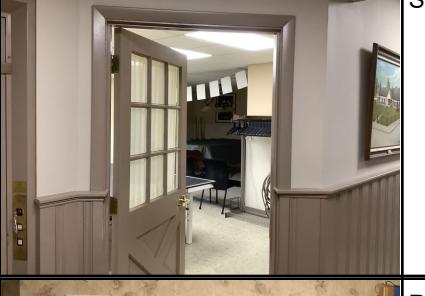
Signage is not provided	-	Locate compliant signage with raised characters and braille alongside the door on the latch side.	3	250	\$750
											750	
69	Classroom 1, Classroom 2, Classroom 3, Nurse Clinic, and Thrift Shop	1	-	Signage	Designation

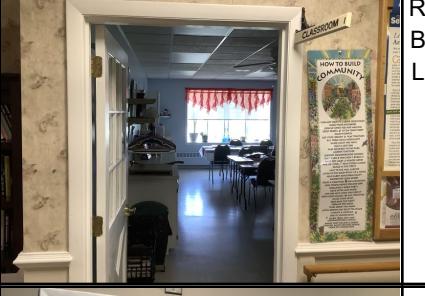
Raised characters not provided on sign Braille not provided on sign Location of tactile sign not compliant	- - -	Provide text with raised characters duplicated in braille on the sign. Locate sign alongside the door on the latch side.	5	325	\$1625

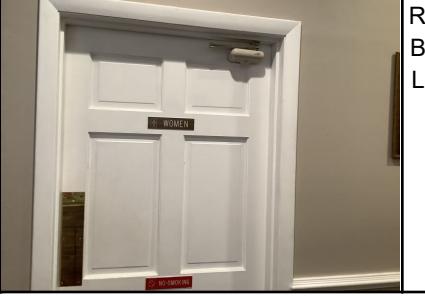
Raised characters not provided on sign Braille not provided on sign Location of tactile sign not compliant	- - -	Provide text with raised characters duplicated in braille on the sign. Locate sign alongside the door on the latch side.	2	250	\$500
											500

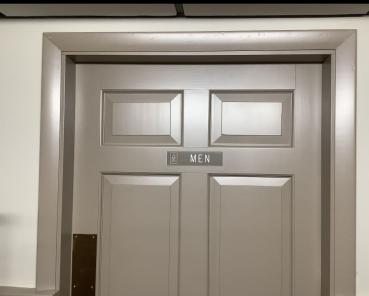
Raised characters not provided on sign Braille not provided on sign Location of tactile sign not compliant	- - -	Provide text with raised characters duplicated in braille on the signs, and locate the signs alongside the door on the latch side.	2	250	\$500
72	Level 1 Corridor/ Elevator	1		Signage	Informational

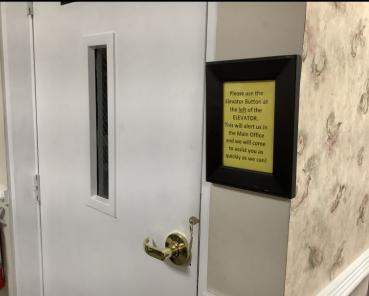
Non-glare finish and contrast not provided on sign	-	Install a sign with a non-glare finish with characters that have a high contrast to the background.	1	250	\$250
Service Counter												
73	Thrift Store	1	-	Service Counter	N/A

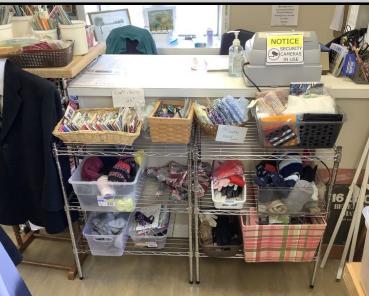
Counter not connected to an accessible route	12" deep	Ensure the counter is connected to an accessible route. All portions of accessible counters must be located adjacent to a walking surface. Relocated the items stored in front of the counter.	1	Labor	Labor

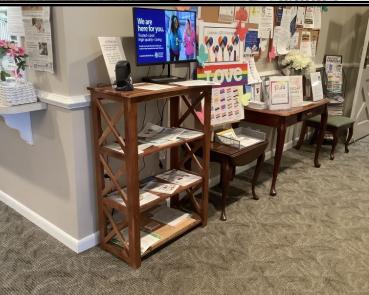
Reach < 15" or > 48"(forward/side approach)	57"	Provide a new table to hold the computer screen so that the highest touch screen controls are between 15"- 48" above the finished floor.	1	455	\$455
												455

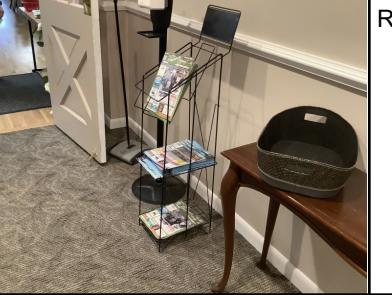
Reach < 15" or > 48"(forward/side approach)	3"	Ensure that all flyers, brochures and magazines are located within reach range or ensure that staff is able to help visitors who need assistance.	1	Labor	Labor
77	Classroom 1, Classroom 2, Changing Room in Thrift Store	1	-	Operable Parts / Reach Range	Clothes Rod/Hooks

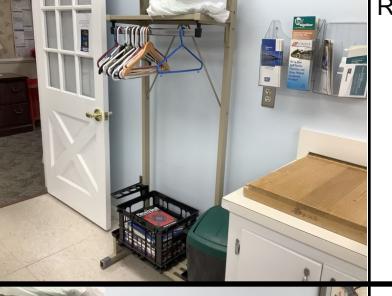
Reach < 15" or > 48"(forward/side approach)	60"	Provide a coat hook that is no higher than 48" above the finished floor.	3	75	\$225 225
78	Classroom 1	1	-	Operable Parts / Reach Range	Pamphlet Holder

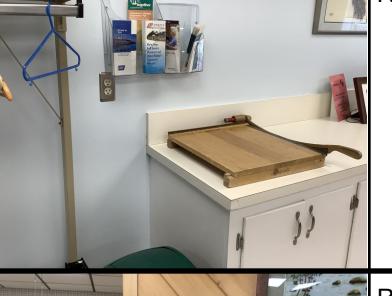
Reach < 15" or > 48"(forward/side approach)	54"	Ensure that all flyers, brochures and magazines are located within reach range or ensure that staff is able to help visitors who need assistance.	1	Labor	Labor

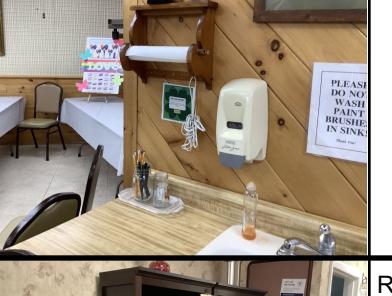
79	Classroom 2	1	-	Operable Parts / Reach Range	Paper Towel Dispensar

Reach < 15" or > 48"(forward/side approach)	59"	Relocate paper towel dispenser so that controls are between 15"- 48" above the finished floor.	1	500	\$500 500
80	Level 1 Corridor	1	-	Operable Parts / Reach Range	Bookshelf

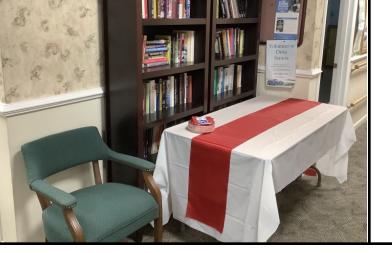
Reach < 15" or > 48"(forward/side approach)	57.5"	Ensure that staff is available to assist visitors who need assistance.	1	Labor	Labor

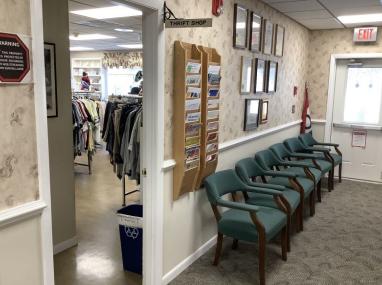
Reach < 15" or > 48"(forward/side approach)	69"	Ensure that all flyers, brochures and magazines are located within reach range or ensure that staff is able to help visitors who need assistance. When new designation sign is installed on the latch side of the door, the pamphlet holder should be moved so it does not block 18" x 18" clear floor space for the designation sign.	1	Labor	Labor
82	Level 1 Corridor	1	-	Operable Parts / Reach Range	Magazine Stand

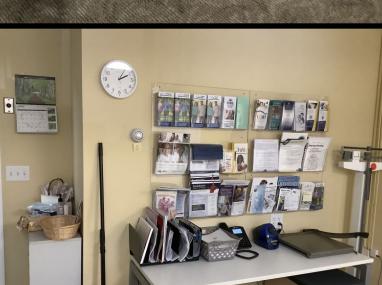
Reach < 15" or > 48"(forward/side approach)	69"	Ensure that staff is available to assist visitors who need assistance.	1	Labor	Labor

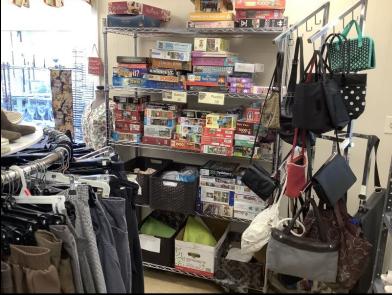
Reach < 15" or > 48"(forward/side approach)	73.75"	Ensure that staff is available to assist visitors who need assistance with all products located higher than allowed.	1	Labor	Labor
87	Basement Corridor, Game Room	B	-	Operable Parts / Reach Range	Clothes Rod/Hooks

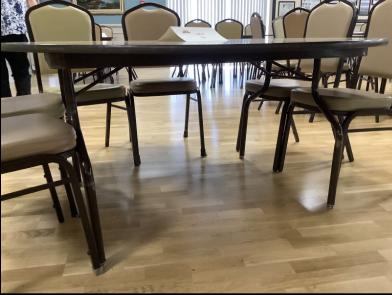
Knee or toe clearance not provided Knee clearance less than 19" deep	26" 10.5"	Provide at least one dining or work surface with 27" min. high knee and toe clearance, and with knee clearance that is 19" deep min.	1	1100	\$1100
											1100	
92	Clinic	1	-	Dining or Work Surfaces	Work Surface

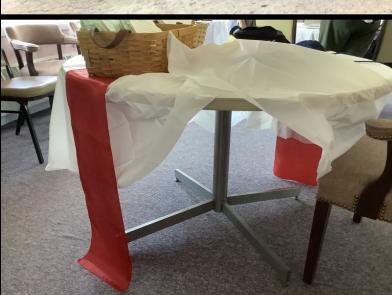
1100	
94	Classroom 3	1	-	Dining or Work Surfaces	Work Surface

Knee or toe clearance not provided Knee clearance less than 19" deep	27" width 5"	Provide at least one dining or work surface with 27" min. high knee and toe clearance. For children, provide at least one dining or work surface with 24" min. high knee and toe clearance. Provide at least one dining or work surface with knee clearance that is 19" deep min.	1	700	\$700
											700	
95	Meeting Space	B	-	Dining or Work Surfaces	Work Surface

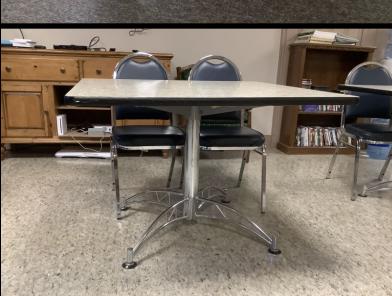
Knee or toe clearance not provided Knee clearance less than 19" deep	26" wide 10"	Provide at least one dining or work surface with 27" min. high knee and toe clearance. Provide at least one dining or work surface with knee clearance that is 19" deep min.	1	700	\$700
											700

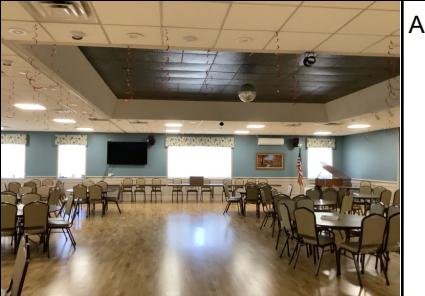
Assistive listening devices not provided		If audible communication is integral to the use of the space, provide an assistive listening system.	1	5123	\$5123
											5123	
97	Meeting Space	B	-	Assembly Area	N/A

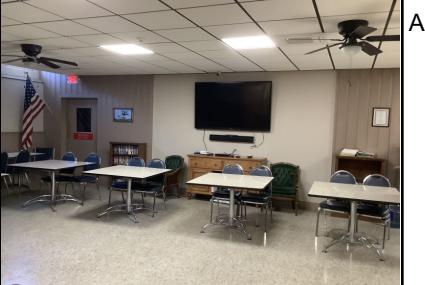
Assistive listening devices not provided	-	If audible communication is integral to the use of the space, provide an assistive listening system.	1	1578	\$1578
											1578	
Locker Room												
98	Thrift Store	1	-	Locker Room	Single User

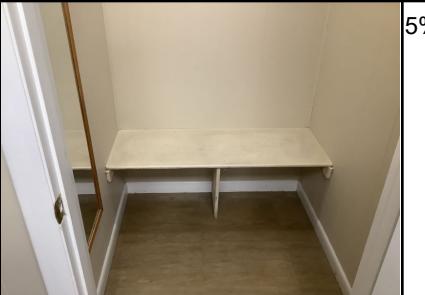
5% of changing rooms are not accessible	-	Ensure that 5% of changing rooms (at least one) are accessible.	1	7626	\$7626
											7626	
Toilet & Bathing Rooms												
Overall Access												
99	Toilet Room in Clinic	1	-	Overall Access	Toilet Room

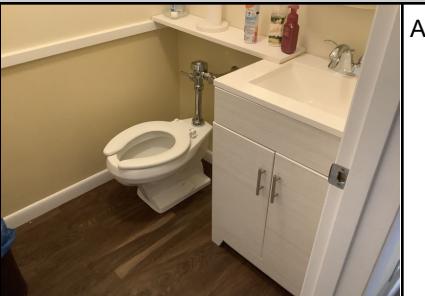
Accessible plumbing fixtures or stalls not provided	-	Provide an accessible single-user toilet room.	1	31985	\$31985

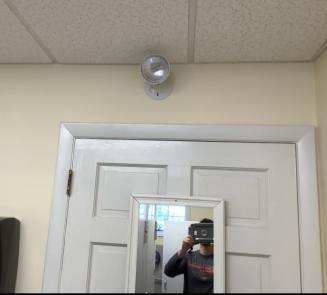
Audible alarm not provided	-	When fire system is updated, ensure that an audible fire alarm is installed.	2	-	-
101	Men's Multi-User Toilet Room	B	-	Overall Access	Toilet Room

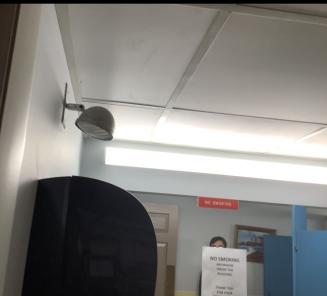
Audible alarm not provided	-	When fire system is updated, ensure that an audible fire alarm is installed.	1	-	-
Lavatory												
102	Men's Multi-User Toilet Room	1	-	Lavatory	N/A

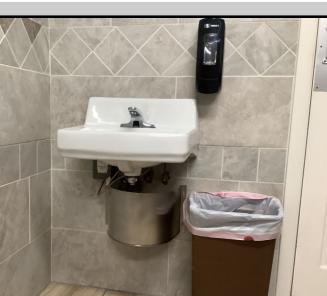
Toe or knee clearances not provided Mirror above lavatory w/reflective surface > 40"	26" 53"	Provide at least one lavatory with knee and toe clearance positioned for a forward approach. Lower mirror so that the bottom surface is at 40" max. above the finished floor.	1	2192 500	\$2692 2692
103	Women's Multi-User Toilet Room	1	-	Lavatory	N/A

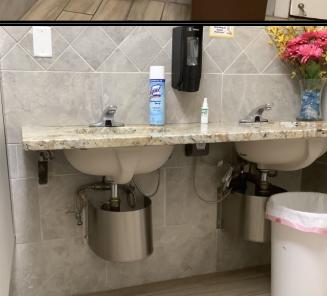
Toe or knee clearances not provided Plumbing underneath is exposed Mirror above lavatory w/reflective surface > 40"	25.25" - 53"	Provide at least one lavatory with knee and toe clearance positioned for a forward approach. Insulate or otherwise configure pipes to prevent contact for at least one lavatory. Lower mirror so that the bottom surface is at 40" max. above the finished floor.	1	2192 500	\$2692 2692

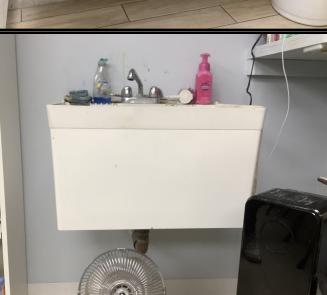
Toe or knee clearances not provided Lavatory rim or counter > 34" high Faucet is not compliant Plumbing underneath is exposed	21" 35" - -	Provide at least one additional lavatory with knee and toe clearance positioned for a forward approach.	1	2192	\$2192 2192

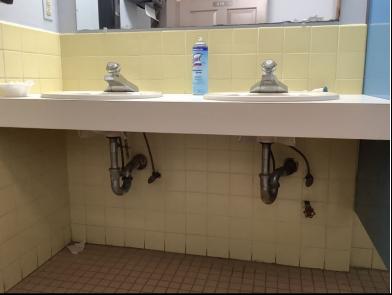
Faucet is not compliant Plumbing underneath is exposed Mirror above lavatory w/reflective surface > 40"	- - 43"	Provide a faucet that can be operable with one hand and not require tight grasping, pinching, or twisting of the wrist for at least one lavatory. Insulate or otherwise configure pipes to prevent contact for at least one lavatory. Lower mirror so that the bottom surface is at 40" max. above the finished floor.	2	150 500 1300	\$1300
Toilet Compartment												
106	Women's Multi-User Toilet Room	1	-	Toilet Compartment	Accessible Compartment

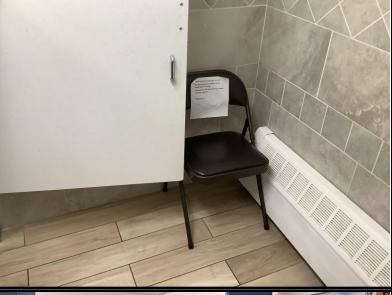
Move chair so that the door can open a full 90 degrees.	1	Labor	Labor
107	Men's and Women's Multi-User Toilet Rooms	B	-	Toilet Compartment	Accessible Compartment

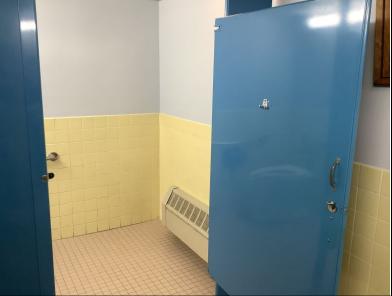
Door has malfunctioning self-closing hinge	-	Repair hinge.	2	Labor	Labor

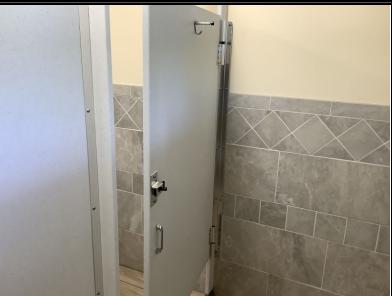
Door has malfunctioning self-closing hinge Coat hook > 48" (2010 ADA)	- 65"	Repair hinge. Locate the coat hook no higher than 48" above the finished floor.	1 75	Labor 75	\$75
109	Women's Multi-User Toilet Rooms	B	-	Toilet Compartment	Accessible Compartment

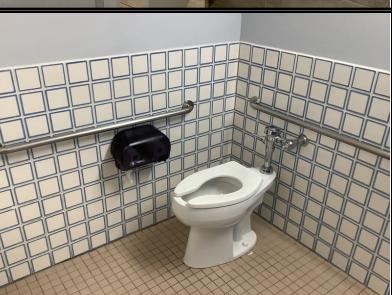
Toilet seat <17" or > 19" high Flush control not on open side Centerline < or > 18" (MAAB)	20"- 16"	Install a toilet with a seat height 17"- 19" above the finished floor. Provide the flush control on the open side of the toilet (transfer side). Relocate toilet so the centerline is 18" from the side wall.	1 3676	3676	\$3676

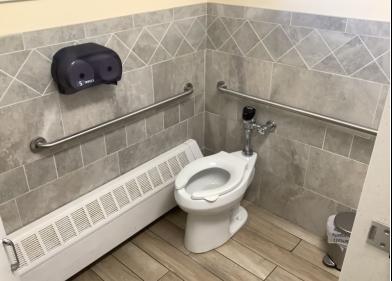
ID	Location	Floor	Room	Element	Type	Photo	Issues	Current Measure	Recommendations	Quantity	Price	Cost Estimation
110	Women's Multi-User Toilet Room	1	-	Toilet Compartment	Accessible Compartment

Clearance in front of the toilet < 42" clear deep (MAAB)	17"	Ensure there is a 42" min. clearance between the toilet and the nearest obstacle	1	7966	\$7966
											7966	
111	Women's Multi-User Toilet Room	B	-	Toilet Compartment	Accessible Compartment

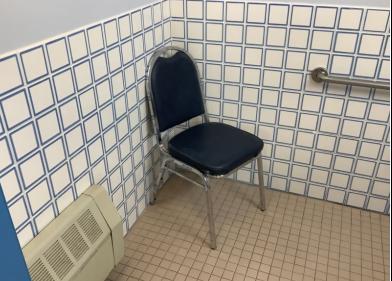
Clearance at toilet < 72" clear depth (MAAB)	-	Move chair.	1	Labor	Labor
112	Men's Multi-User Toilet Room	1	-	Toilet Compartment	Accessible Compartment

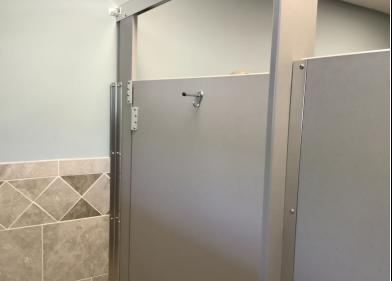
Coat hook > 54" (1990 ADA)	65"	Locate the coat hook no higher than 48" above the finished floor.	1	75	\$75
											75	
113	Men's and Women's Multi-User Toilet Rooms	B	-	Toilet Compartment

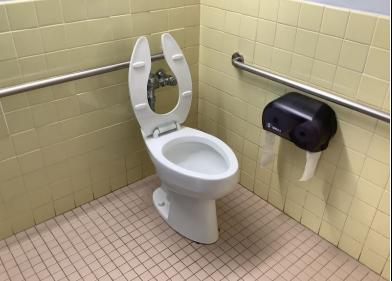
Toilet seat <17" or > 19" high Centerline < or > 18" (MAAB)	20" 16"	Install a toilet with a seat height 17"- 19" above the finished floor. Relocate toilet so the centerline is 18" from the side wall.	2	3676	\$7352

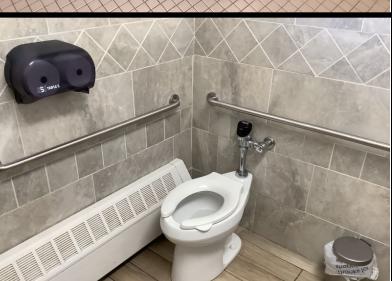
7352	
114	Women's and Men's Multi-User Toilet Rooms	1	-	Toilet Compartment	Accessible Compartment

Noncompliant toilet paper dispenser Centerline < or > 18" (MAAB) Side grab bar < 54" from back wall	- 16" 49.5"	Relocate toilet paper so that it is 24" min. high, located under the grab bar, and between 7" and 9" from the front of the toilet Relocate toilet so the centerline is 18" from the side wall. Provide a side wall grab bar that is 42" long min. located 12" max. from the rear wall.	2	500 3676 800	\$9952
											9952

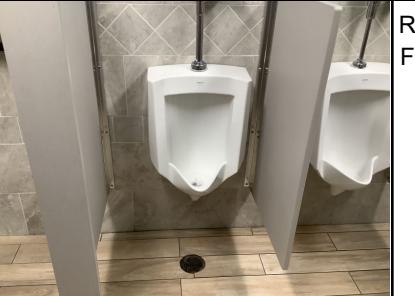
ID	Location	Floor	Room	Element	Type	Photo	Issues	Current Measure	Recommendations	Quantity	Price	Cost Estimation
Urinal												
115	Men's Multi-User Toilet Room	1	-	Urinal	N/A

Rim > 17" high Flush control too high or not properly located	22" 58"	Provide at least one urinal with the rim no higher than 17" above the finished floor. Mount flush control at 44" max. above the finished floor.	1	4222 500	\$4722
												4722
116	Men's Multi-User Toilet Room	B	-	Urinal	N/A

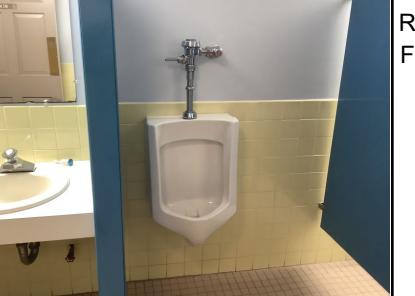
Rim > 17" high Flush control too high or not properly located	22" 52"	Provide at least one urinal with the rim no higher than 17" above the finished floor. Mount flush control at 44" max. above the finished floor.	1	2111 500	\$2611
												2611
Dispensers												
117	Women's and Men's Multi-User Toilet Rooms	1	-	Dispensers	Paper Towel Dispenser

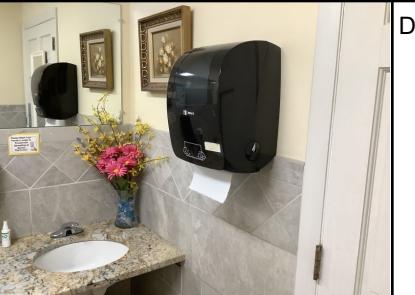
Dispenser acts as a protruding object	9.75"	Relocate dispenser out of the circulation path.	2	500	\$1000

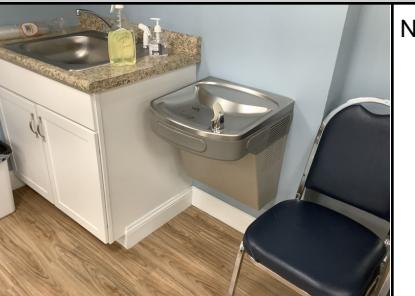
No drinking fountain provided for standing users	-	Provide an additional drinking fountain for standing users.	1	4028	\$4028
												4028

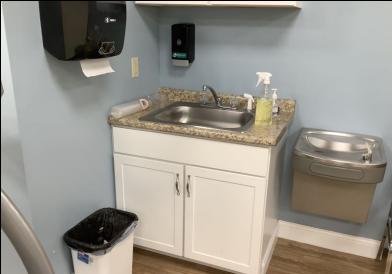
ID	Location	Floor	Room	Element	Type	Photo	Issues	Current Measure	Recommendations	Quantity	Price	Cost Estimation
Sink												
119	Gym	B	-	Sink	N/A

Clear floor space not provided at sink Toe and knee clearances not provided Rim or counter > 34" Noncompliant faucet	- - 36" -	Provide a 30" by 48" clear floor space positioned for a forward approach. Ensure there is a 27" min. knee clearance positioned for a forward approach. Relocate sink with the front of the rim or counter no higher than 34" above the finished floor. Install faucets that do not require tight grasping, pinching, or twisting of the wrist.	1	4022 1282	\$5304 5304
120	Classroom 2	1	-	Sink	N/A

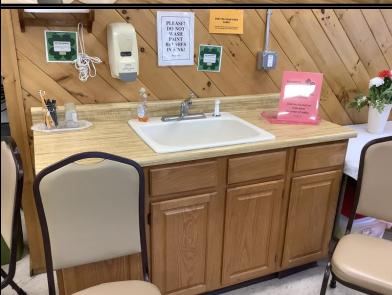
Toe and knee clearances not provided Rim or counter > 34"	- 36.5"	Remove cabinets to ensure there is a 27" min. knee clearance positioned for a forward approach. Relocate sink with the front of the rim or counter no higher than 34" above the finished floor.	1	4022	\$4022 4022

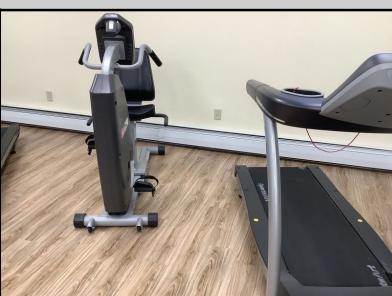
Play and Sport Areas												
Exercise Machines												
121	Gym	B	-	Exercise Machines	N/A

Clear floor space not provided	19"	Ensure that one of each type of equipment has a 30" by 48" clear floor space positioned for transfer or for use by an individual seated in a wheelchair. Clear floor space required at exercise machines and equipment shall be permitted to overlap. Applies to all unique exercise machines.	1	Labor	Labor
Best Practice												
122	Level 1 Ramp	1	-

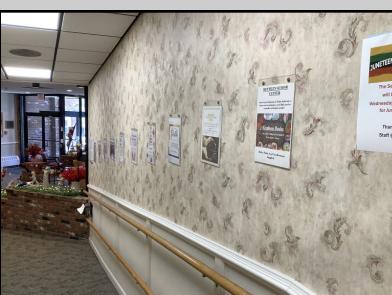
Recommend providing anti-reflective covers over these signs to prevent glare.	1	-	-

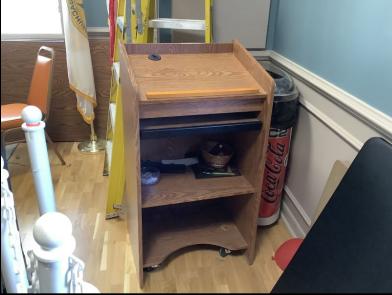
Recommend providing an adjustable height podium with knee and toe clearance.	1	-	-
124	Basement Corridor/ Ceramics Room	B	-

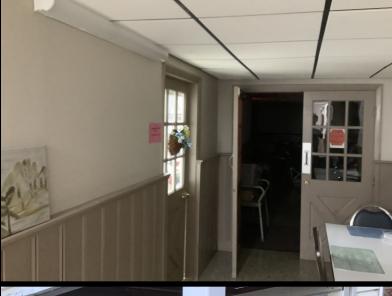
Recommend fixing lighting next to ceramics room entrance in corridor outside.	1	-	-
125	Accessible Parking by Back Entrance	Ext.	-

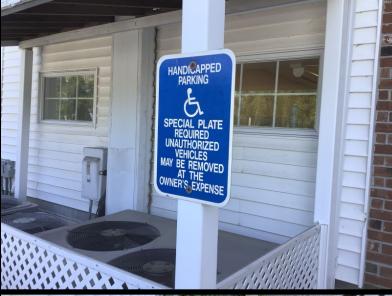
Recommend using the term "Accessible Parking" instead of "Handicapped Parking".	1	-	-
126	Entrance Door to Thrift Shop	Ext.	-

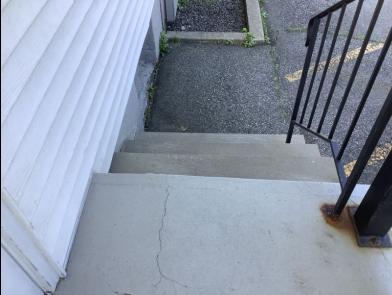
Recommend providing a solid and continuous stripe applied to the horizontal leading edge of each stair tread so that each tread is readily apparent when viewed in descent at each stair in the building.	1	-	-
