# INDOOR AIR QUALITY ASSESSMENT

## **Marsh Grammar School**

309 Pelham Street

January 2025

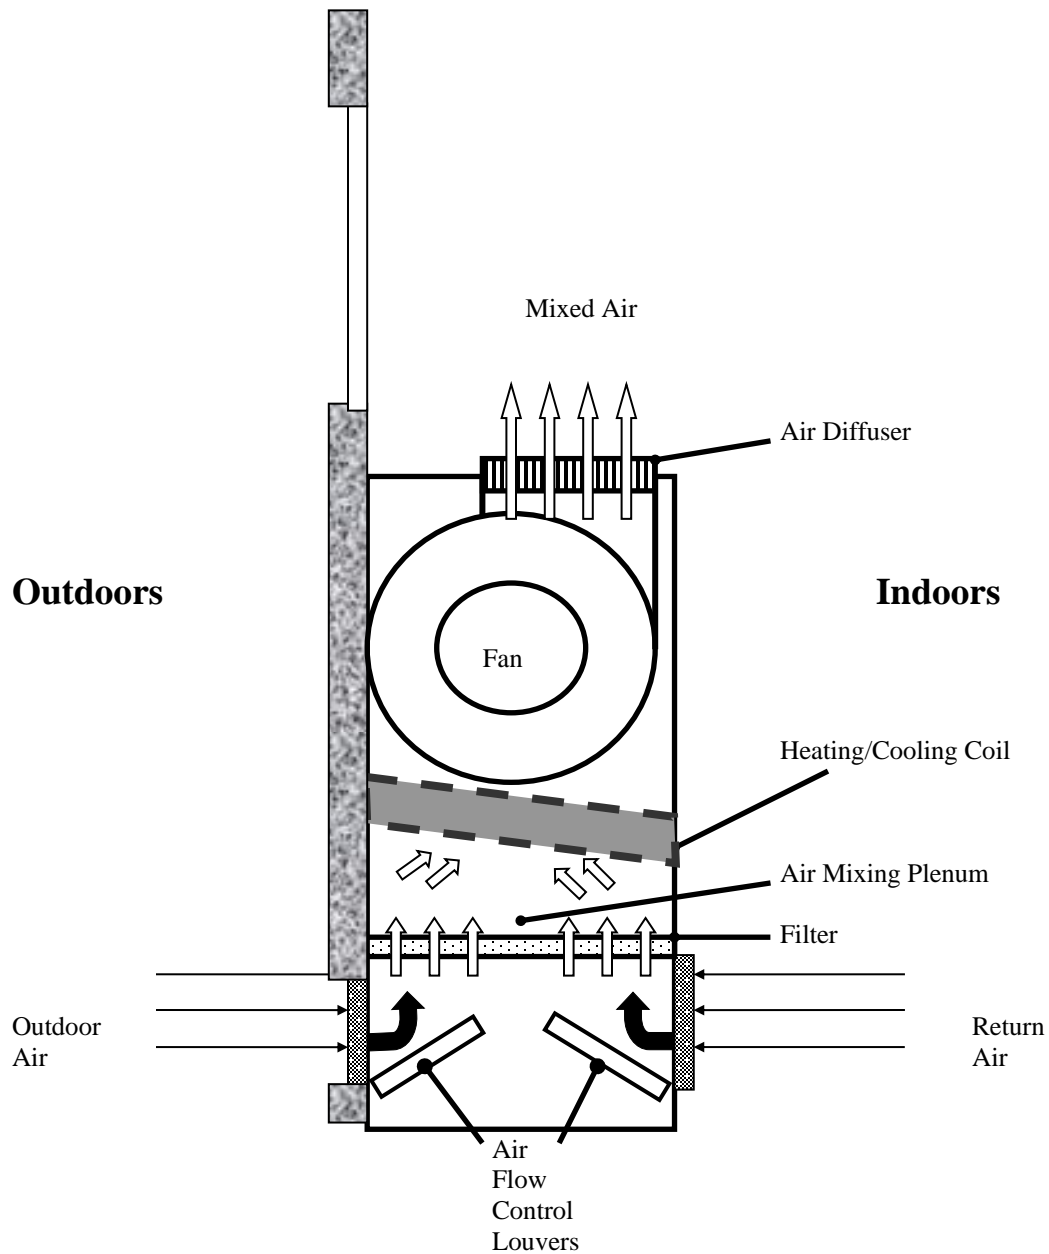
**Figure 1**  
**Unit Ventilator (Univent)**

Most classrooms are equipped with unit ventilators (univent, Picture 1). Univents bring in fresh air from a vent on the outside of the building (Picture 2), filter, heat or cool it, and supply the air through a vent on the top. Some room air is recirculated along with the fresh air through a vent at the bottom (Figure 1). The univents are reported to be controlled by a newly-installed computerized management system. During the assessment, a number of univents were in the off cycle or deactivated (Table 1), therefore no means of mechanical fresh air was being provided.

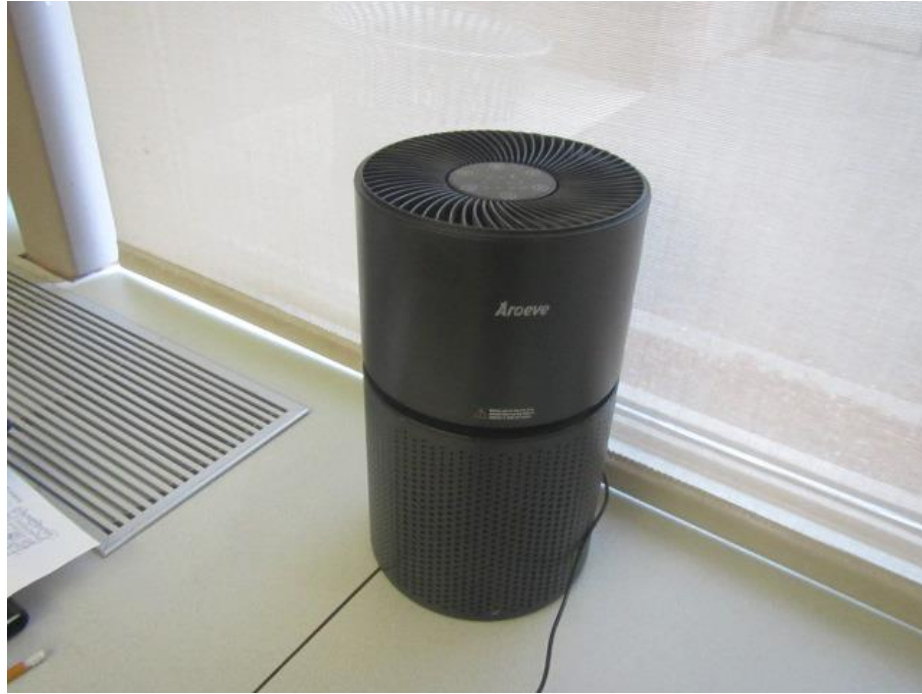
Picture 33

- Finally, high-efficiency particulate arrestance (HEPA) air purifiers, were in use in several classrooms (Picture 33). HEPA units remove up to 99% of airborne contaminants as small as 0.1 microns including airborne mold spores. These are good choices for use in occupied areas. Air purifiers that may produce ozone should not be used (EPA, 2003). All air purifiers should be cleaned and maintained in accordance with manufacturers’ instructions.

Air purifier in classroom
